2017 Ford Mustang V8-5.0L

DEMONSTRATION / DELIVERY HOLD - COMPLIANCE RECALL 17C04 - LEFT-HAND INTERIOR DOOR HANDLE SPRING INSPECTION

SUBJECT: DEMONSTRATION / DELIVERY HOLD - Compliance Recall 17C04

Left-Hand Interior Door Handle Spring Inspection

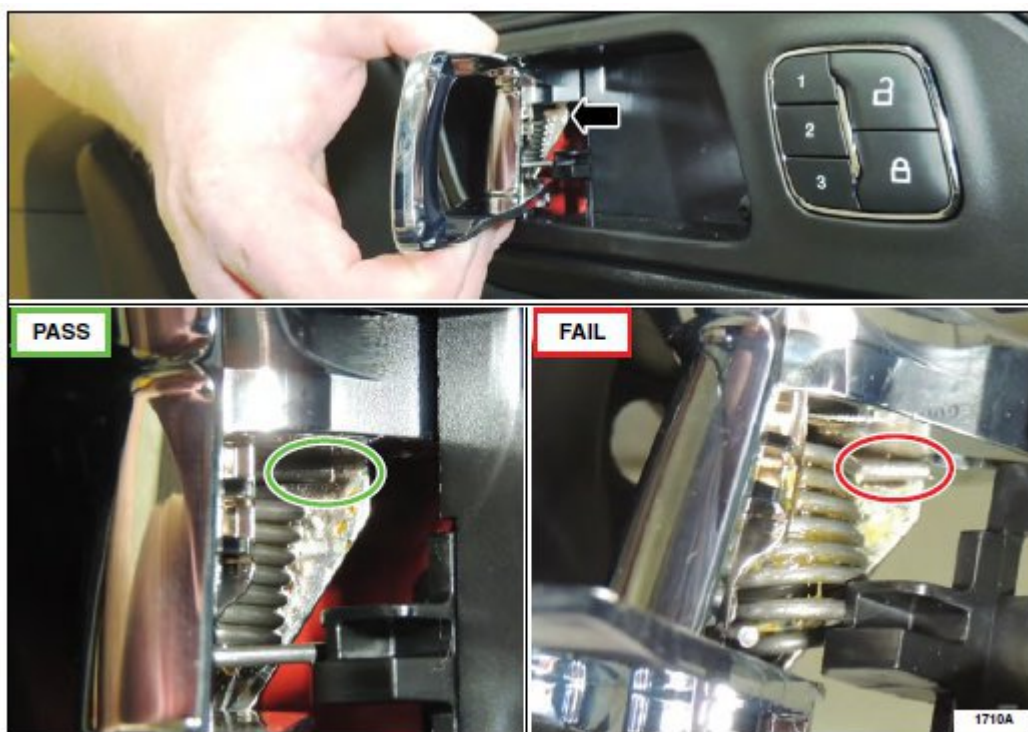
FIGURE 1

Some of the affected vehicles may not conform to the requirements specified by Federal Motor Vehicle Safety Standard (FMVSS) 206 S4.1.1.4, Door Locks & Door Retention Components – Inertial Load Requirement. A spring inside the left-hand interior door handle may be installed incorrectly. If the spring becomes unseated, the door could unlatch during a side impact, increasing the risk of injury in a crash.

1. Inspect the position of the spring inside the left-hand (LH) interior front door handle. See Figure 1.
 - If the spring is correctly installed, the spring tail will be approximately 3 mm (0.1 in) from the edge of the door handle spring wall. No service is required.
 - If the spring tail is flush or above the edge of the door handle spring wall OR the spring is missing, proceed to Step 2.

2. Remove the LH interior front door handle. Please follow the Workshop Manual (WSM) procedures in Section 501-14.

- If the spring is installed incorrectly, remove the spring then proceed to Step 4.

3. If the spring is missing, it may be located behind the door trim panel or inside the vehicle passenger compartment. Was the spring recovered?

NO - Install a *new* LH interior front door handle. Please follow the WSM procedures in Section 501-14. Service is complete.

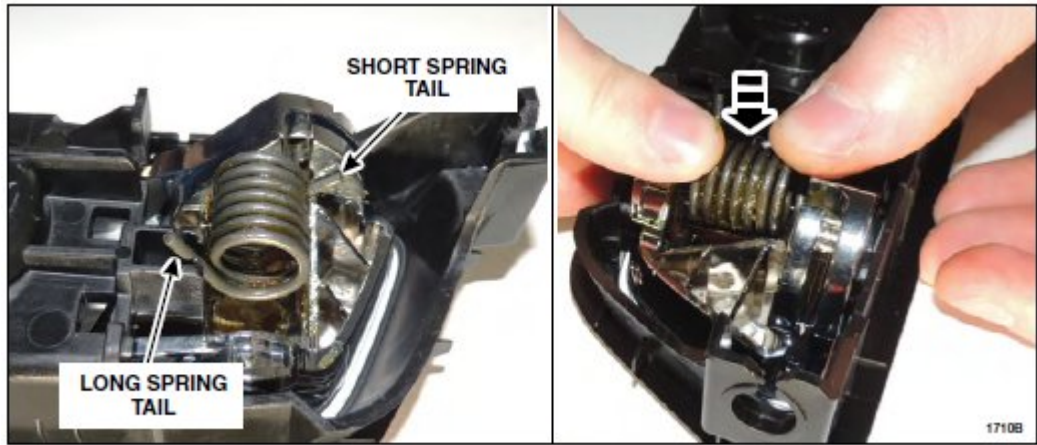
FIGURE 2

- When installed correctly the longer spring tail should face forward, toward the front of the vehicle when the handle is reinstalled.

4. Reinstall the spring into the LH interior front door handle in the correct orientation. Press downward until the spring is fully seated. See Figure 2.

5. Install the LH interior front door handle. Please follow the WSM procedures in Section 501-14.
