2018 Ford Mustang V8-5.0L

SAFETY RECALL 18S09 - VEHICLES EQUIPPED WITH A 10R80 TRANSMISSION - PARK PAWL GUIDE CUP ROLL PIN INSPECTION

SUBJECT: **NEW VEHICLE DEMONSTRATION / DELIVERY HOLD – Safety Recall 18S09**
Certain 2017-2018 Model Year F-150 and 2018 Expedition, Navigator and Mustang
Vehicles Equipped with a 10R80 Transmission
Park Pawl Guide Cup Roll Pin Inspection

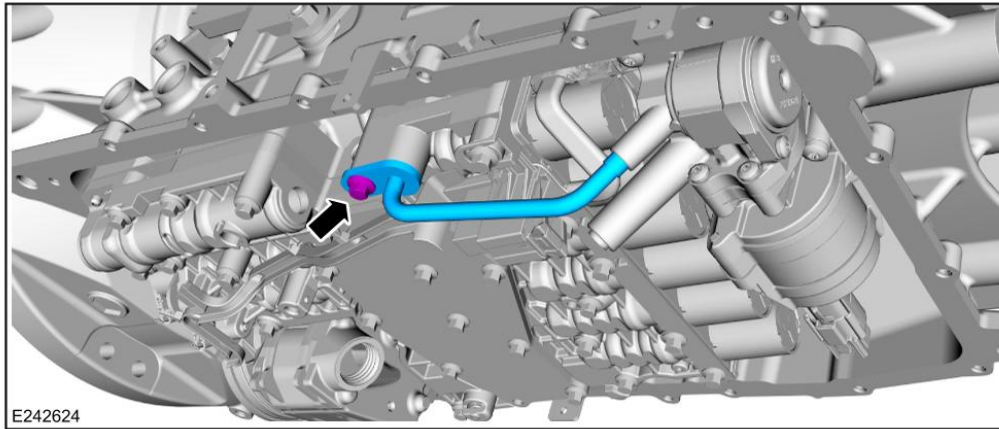
FIGURE 1

3. Remove the bolt and the transmission fluid auxiliary pump tube. See Figure 1.

- Tighten to 106 lb.in (12 Nm).

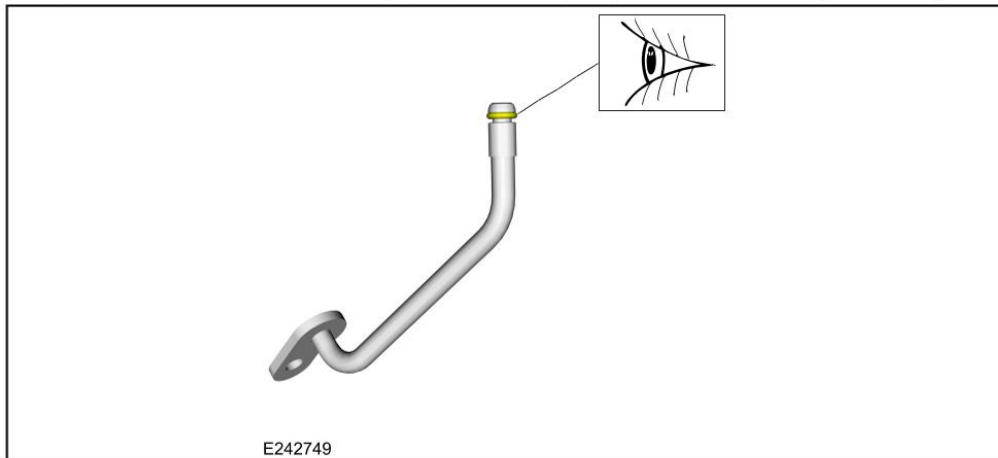
FIGURE 2

4. Inspect the transmission fluid auxiliary pump tube O-ring. Replace if worn or damaged. See Figure 2.

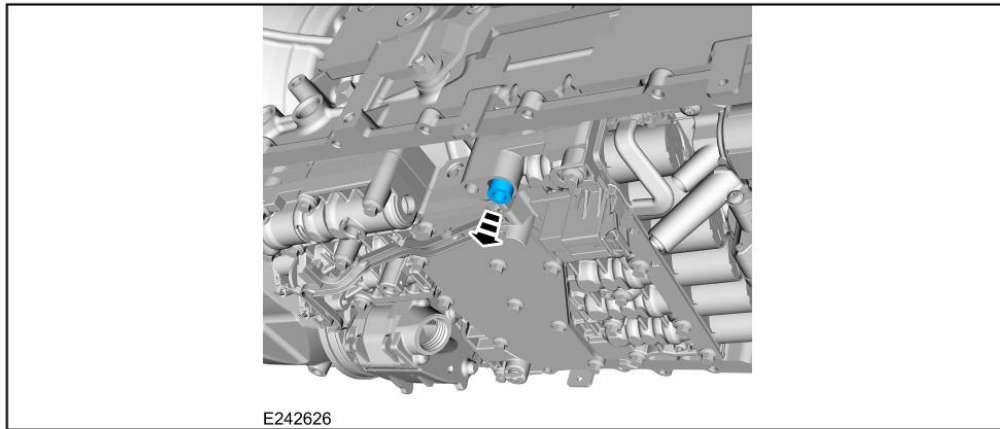
FIGURE 3

5. Remove the transmission fluid auxiliary pump tube seal. See Figure 3.

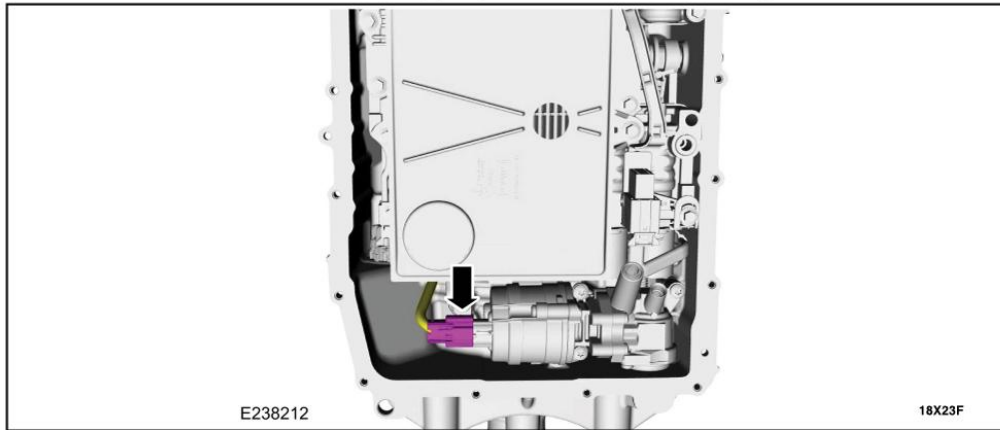
FIGURE 4

6. Disconnect the transmission fluid auxiliary pump electrical connector. See Figure 4.

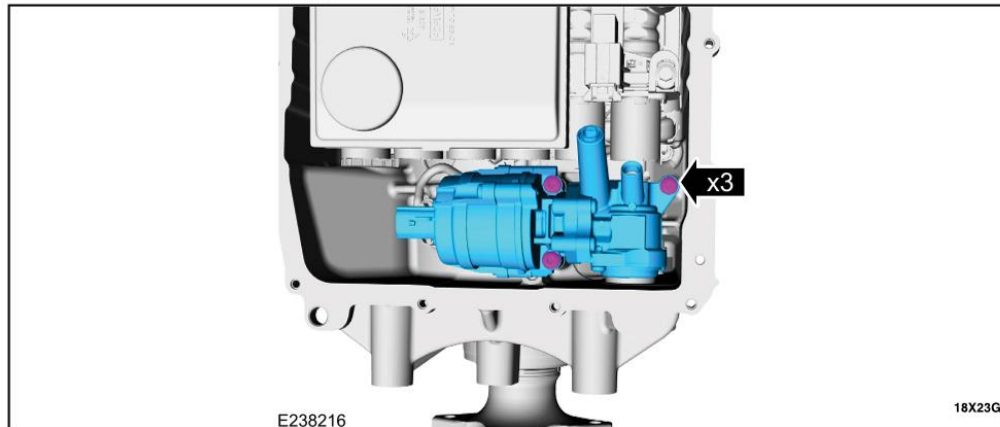
FIGURE 5

7. Remove the bolts and the transmission fluid auxiliary pump. See Figure 5.

- To install tighten bolts to 97 lb.in (11 Nm).

NOTE: Use of the 1/4" T30 stubby torx socket is needed for bolt removal and installation.

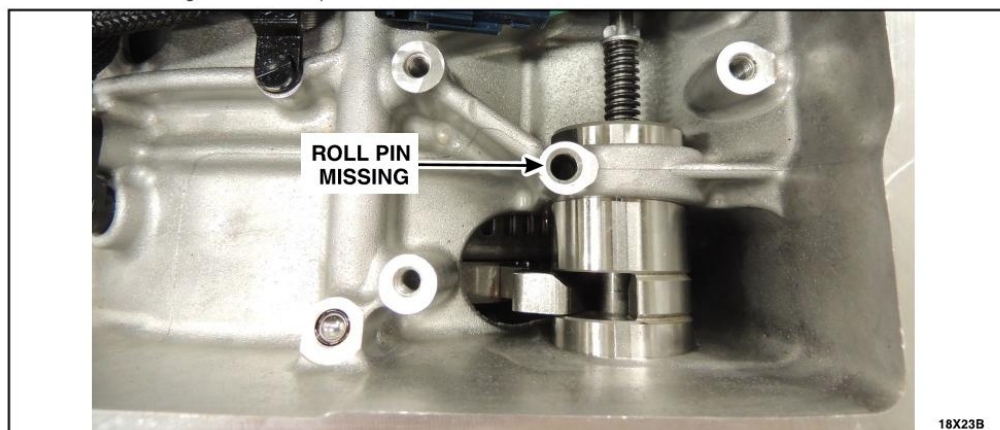
FIGURE 6

In some of the affected vehicles, the park pawl guide roll pin may not have been installed. If the roll pin is missing, the guide cup could move out of position with repeated use. The transmission may eventually lose Park function, even when the shifter and PRNDL display indicate the vehicle is in park.

8. Inspect for the missing park pawl actuator rod sleeve roll pin. See Figure 6.

- If the park pawl actuator rod sleeve roll pin is missing proceed to Step 9.
- If the park pawl actuator rod sleeve roll pin is present, the vehicle can be reassembled by reversing the removal procedure.
