2017 Ford Mustang V8-5.0L

TECHNICAL SERVICE BULLETIN

19-2273

Inoperative Park Aid Camera, Luggage Compartment Lamp, Luggage Compartment Lid Release And/Or Poor Satellite Radio Reception

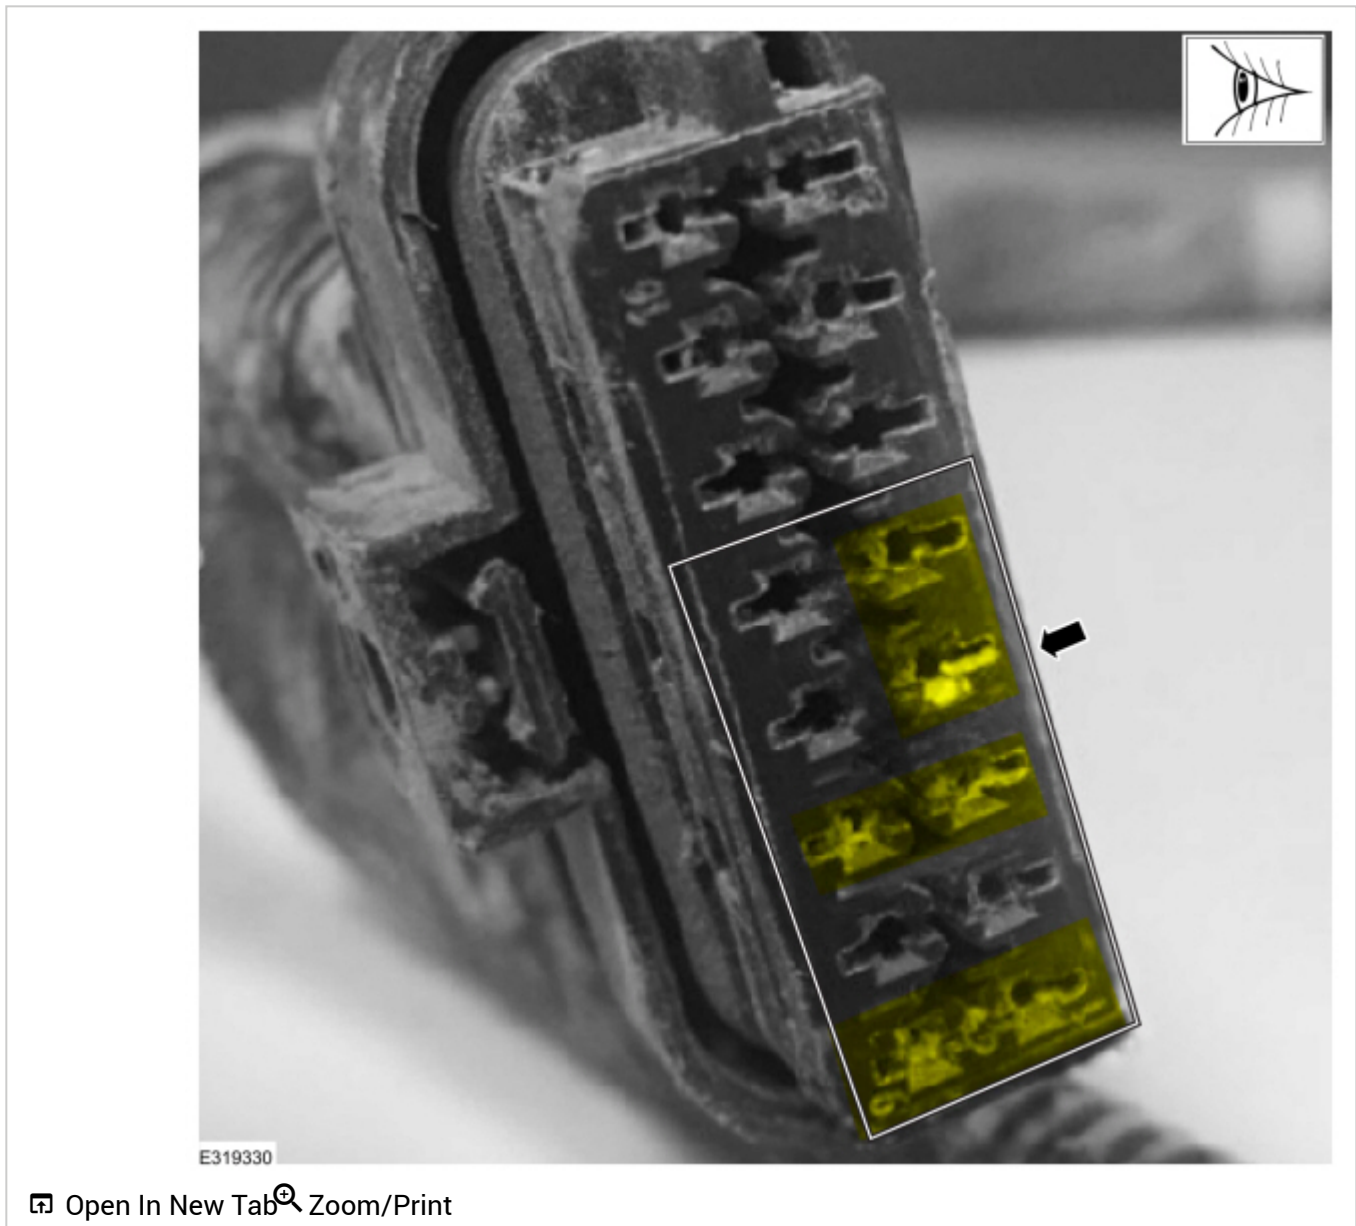
Figure 1

Issue: Some 2015-2017 Mustang vehicles may experience an inoperative rear parking aid camera, luggage compartment lamp, luggage compartment lid release and/or poor satellite radio reception. This may be due to damage to the 14A005 harness in the area of the right side luggage compartment lid hinge. This concern may be accompanied by diagnostic trouble codes (DTCs) B115E, C1001, and B1A89. To resolve the condition, follow the Service Procedure steps to inspect and repair the wiring harness.

1. Cut out the damaged section of the harness. Make the cut at the location of the harness noted. (Figure 1)

2. Splice in the new section of harness, matching wire colors on the existing vehicle harness and the replacement section of harness as necessary. Follow the recommended wiring splice procedures in Section 5 of the Wiring Diagram. Stagger the location of each of the wire splices along the harness to minimize the overall size of the repair.
3. Wrap the spliced area in Coroplast Electrical Wire Harness Tape or equivalent.
4. Secure the replacement section of harness into the same body holes as the original section of harness was using the clips attached to the replacement section of harness.
5. If DTCs were previously present, connect the appropriate Ford scan tool or equivalent to the DLC and clear all DTCs.
