2000 Ford Mustang V6-3.8L VIN 4
Vehicle > Technical Service Bulletins

HOOD - DIFFICULT TO CLOSE

00-21-2

HOOD-HOOD REQUIRES EXCESSIVE EFFORT TO CLOSE-SERVICE TIPS

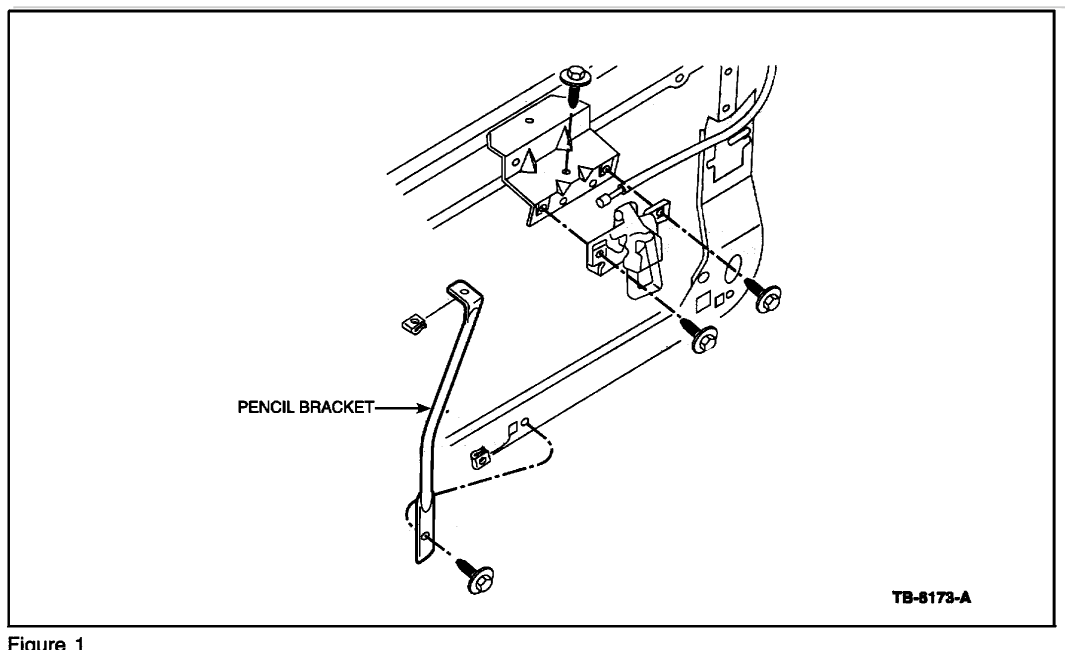
Figure 1

Some vehicles may exhibit a hood that is hard to close. This may be caused by a hood latch support bracket that is improperly adjusted.

1. Loosen the bolt that attaches the pencil bracket to the bottom of the radiator support (Figure 1).
2. Check to see if the hood latch is interfering with the striker (on inside of hood).
 - a. Gently push hood down after engaging secondary latch and see if the hood is forced sideways in either

9. Secure the fastener that attaches the pencil bracket to the bottom of the radiator support to 12 Nm (9 lb-ft) (Figure 1).
