2001 Ford Mustang V6-3.8L VIN 4

A/T - 4R70W CLUNK NOISE ON 2ND TO 1ST GEAR DOWNSHIFT

01-13-7

07/09/01

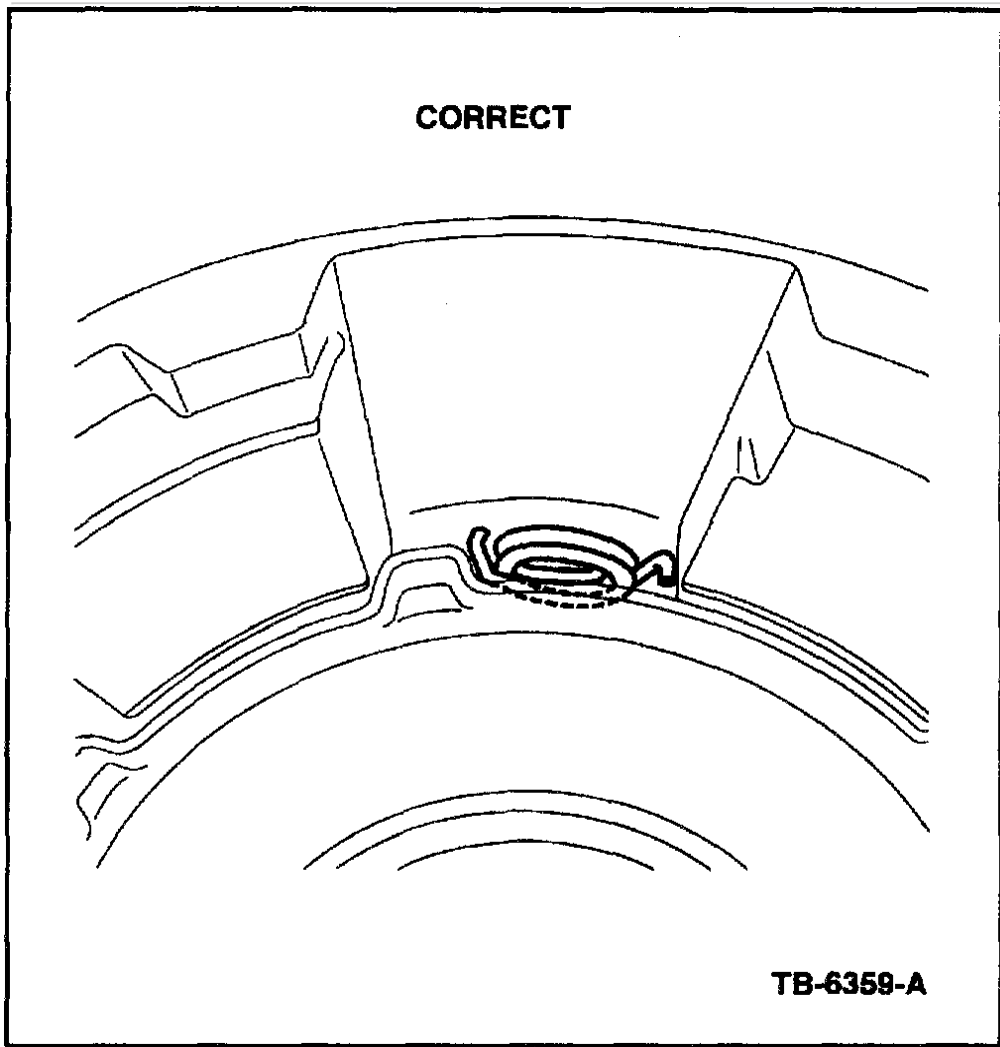
Figure 1

Check for the correct installation of the Planet Support Spring. If the spring is not installed correctly, the Planetary Gear Support will make contact with the transmission case during the 2-1 downshift, causing the "clunk" noise. Refer to the following Service Procedure for details.

6. **Note** the position of the Planet Support Spring. Compare to the correct installation which is illustrated in Figure 1. One tang of the Planet Support Spring should be loaded against the transmission case. The other tang should be loaded against the Planetary Gear Support.

7. Unless the Planet Support Spring is damaged, it may be reinstalled in the transmission correctly. If the spring is damaged, replace with part number F5AZ-7F277-AA.

8. Install the Planet Support Spring in the position illustrated in Figure 1. Use a flat/wide tool, that will apply equal force across the spring. This will ensure the spring is installed squarely with the tangs loading the Transmission Case on one side and the Planetary Gear Support on the other.
