2002 Ford Mustang GT V8-4.6L SOHC VIN X

IGNITION SWITCH - HIGH TURNING EFFORT/MIL ON/DTC'S SET

01-21-13

10/29/01

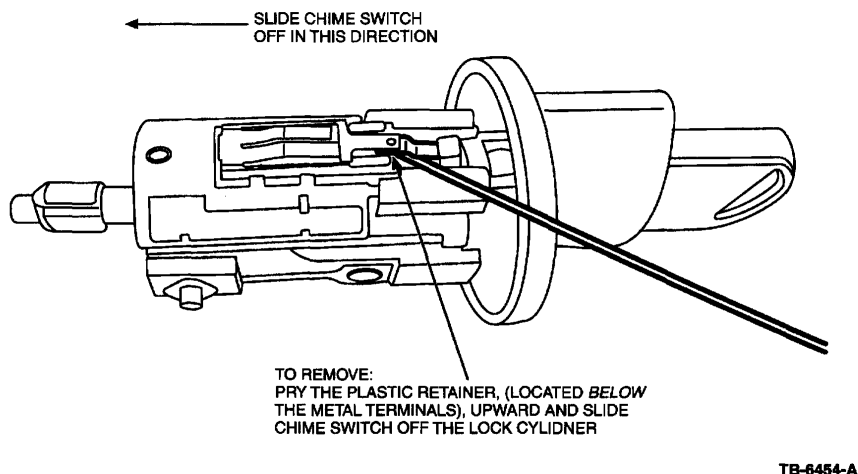
Some ignition switch lock cylinder assemblies may exhibit the following highly intermittent conditions:

^ Roughness and/or excessive effort in turning the key from RUN to START position.

^ Key does not fully return from START to RUN after starting vehicle. This may result in intermittent accessory function.

This may be caused by a Key-In-Ignition warning chime switch.

Replace the KEY-IN-IGNITION WARNING CHIME SWITCH located on the ignition switch lock cylinder with revised part XL2Z-11A127-AB. Refer to the following Service Procedure for details.

4. Remove the Plastic Key chime warning switch by prying upward on the plastic retainer, while sliding the switch away from the key insertion end (Figure 1). Refer to the appropriate model Workshop Manual, Key-in-ignition warning switch removal and installation section located in Section 413 if additional detail is required.
5. Install a new Key-In-Ignition warning chime switch XL2Z-11A127-AB and reinstall lock cylinder.
6. Verify proper function of the Ignition Switch Lock Cylinder and Key-In-Ignition warning chime switch.
