2001 Ford Mustang V6-3.8L VIN 4

M/T - T45 STUCK IN REVERSE/POPS OUT OF REVERSE

01-23-5

TRANSMISSION - T45 MANUAL TRANSMISSION -
STUCK IN REVERSE - DIFFICULT TO SHIFT INTO
REVERSE - POPS OUT OF REVERSE

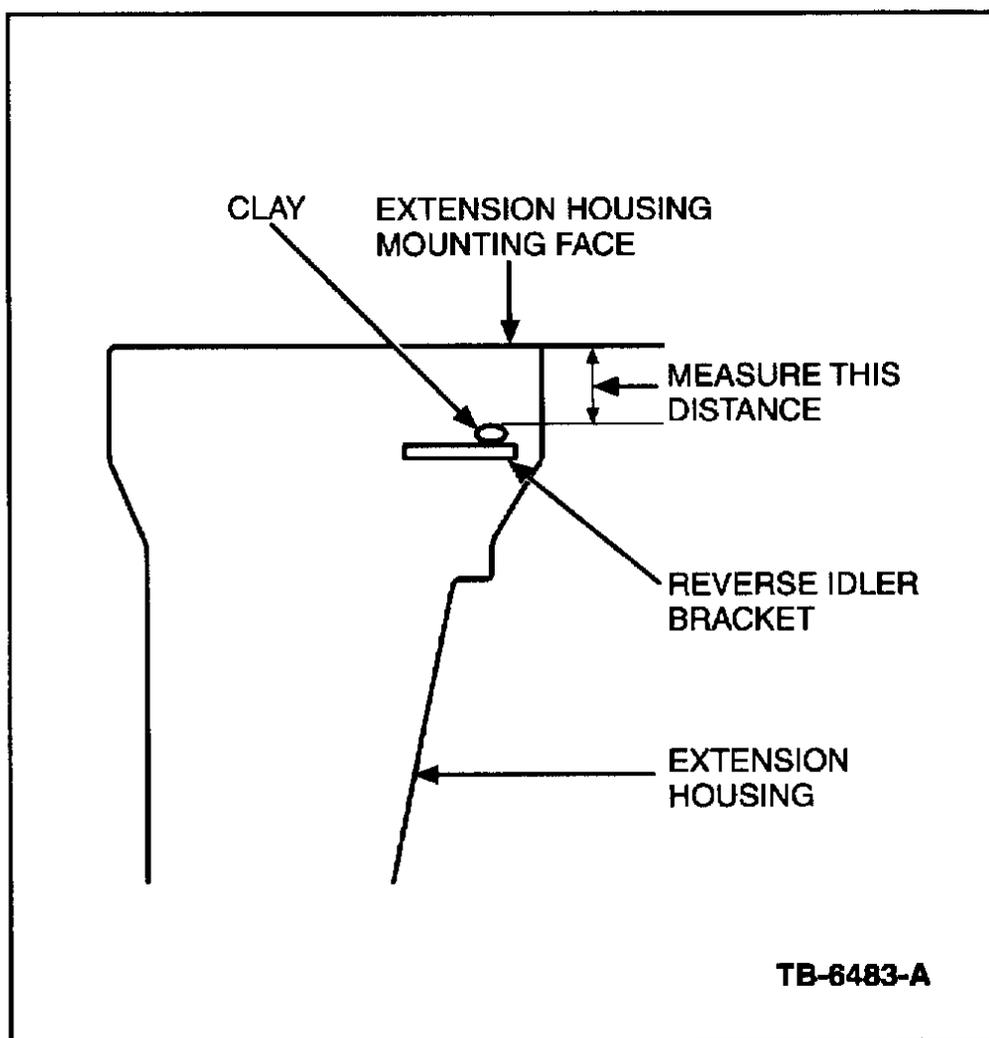
Figure 1

1. While viewing the extension housing from the front, place a small amount of standard modeling clay on the reverse idler bracket (7723) near the 5th/reverse shift rail support hole (near the exterior wall of the housing Figure 1).
