2001 Ford Mustang V6-3.8L VIN 4
Vehicle > Technical Service Bulletins

A/T - 4R70W TICKING NOISE IN 1ST GEAR

01-5-8

March 19, 2001

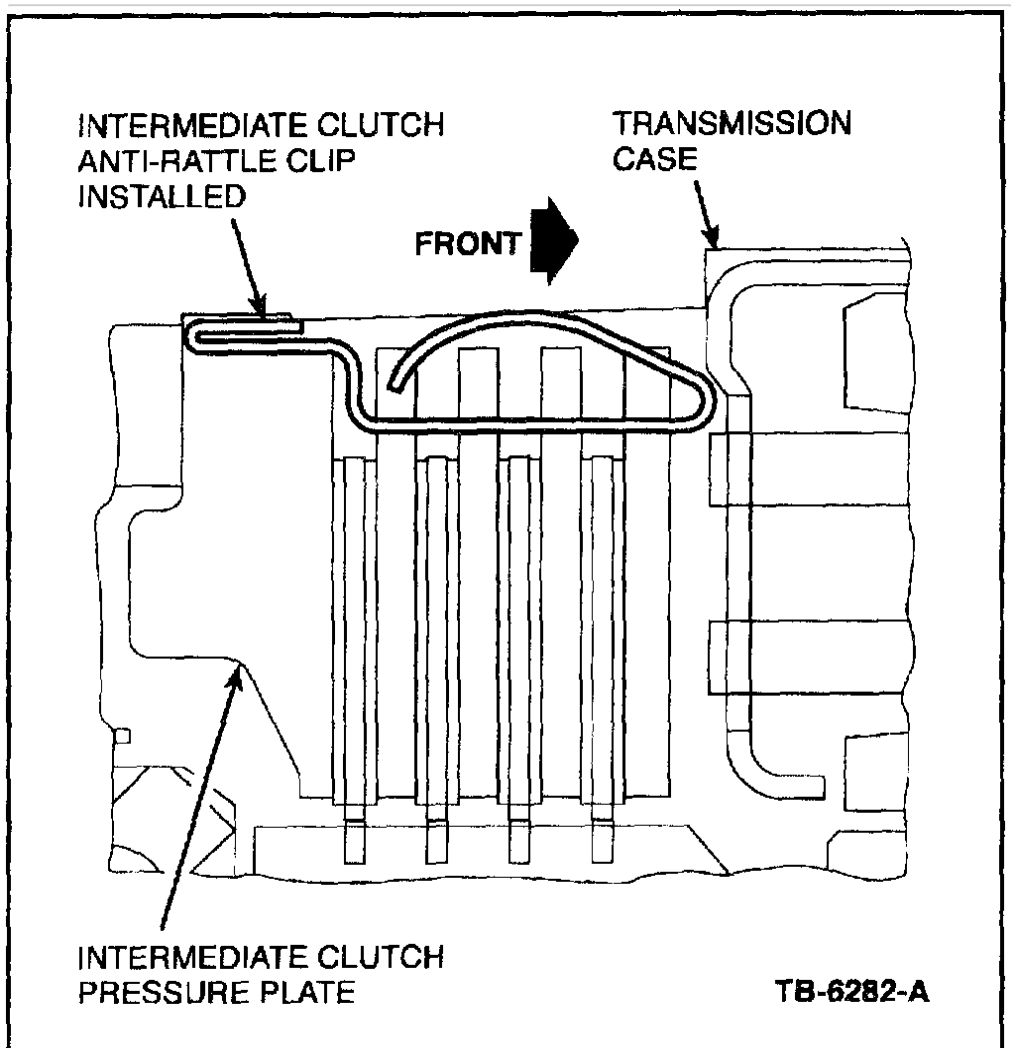
Figure 1

Some vehicles equipped with the 4R70W automatic transmission may exhibit a "Ticking" or "clicking" type noise in first gear. This may be caused by the intermediate clutch moving inside the transmission.

6. Install new Intermediate Clutch Anti-Rattle Clip (YL3Z-7A609-AA) in the center of the 1 o'clock case position. Push clip in until fully seated. (Figures 1 and 2).
7. Check that the intermediate clutch and transmission end clearances are correct. Refer to Workshop Manual, Section 307-01.
8. Install transmission pump assembly using a new Pump Gasket (F2VY-7A1 36-A). Refer to Workshop Manual, Section 307-01.
9. Install the transmission and lower vehicle.
10. Fill transmission to the correct level.
