2003 Ford Mustang V8-4.6L SOHC VIN X

INTERIOR - 'A' PILLAR AREA WIND NOISE

02-17-8

NOISE - WINDNOISE FROM THE "A" PILLAR AREA

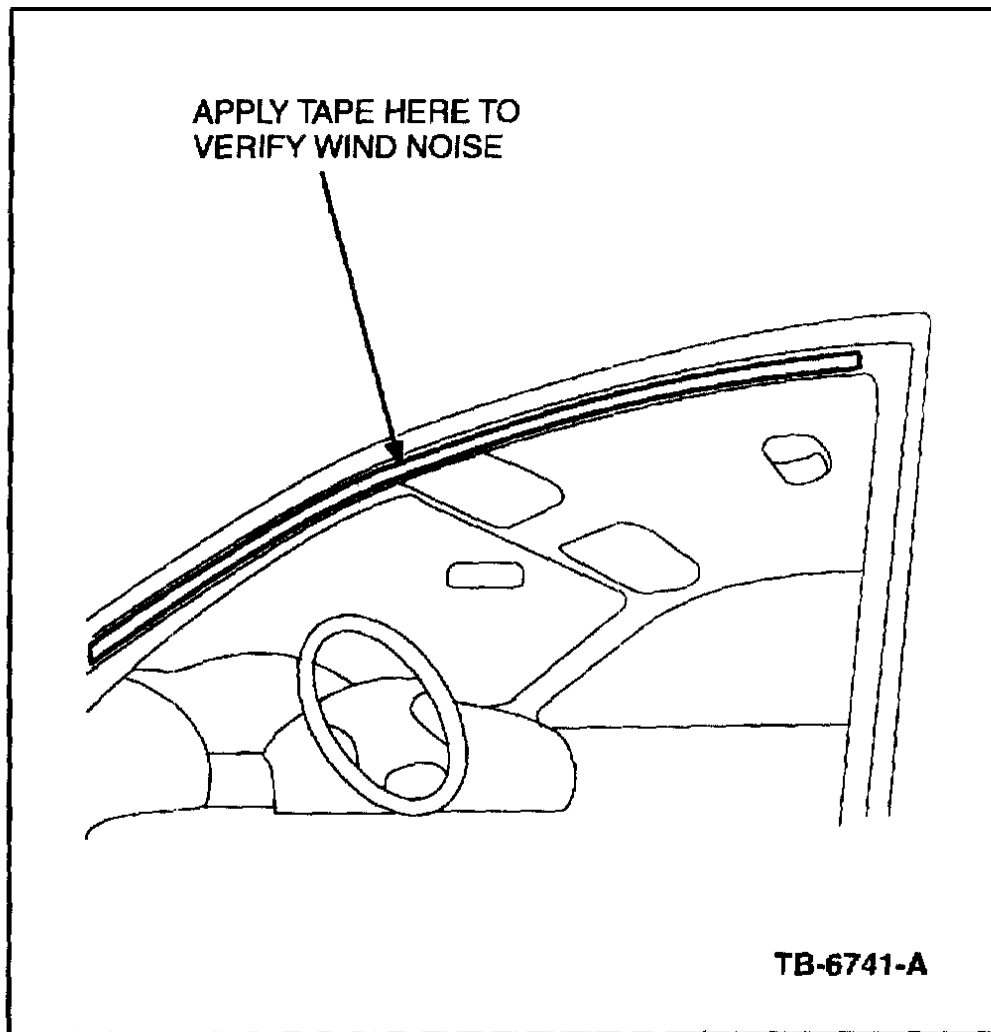
Figure 1

Some 2001-2003 model year Mustangs may exhibit a whistle type windnoise from the "A" pillar area. This may be caused by wind moving over the fastener holes of the "A" pillar applique.

1. Verify windnoise by placing tape the length of the "A" pillar applique (roof moulding) on the door glass side (Figure 1).
2. Drive vehicle and verify that the wind noise is gone.
3. If the noise remains, do not continue with this article. Refer to Workshop Manual Section 100-04 for further diagnosis.
4. If the tape eliminates the noise, remove the tape and remove the A-pillar applique per the Workshop Manual (Section 501-08). Do not continue with the removal of the C-pillar trim.
