2002 Ford Mustang GT V8-4.6L SOHC VIN X

CONVERTIBLE TOP BOOT - POOR FIT

02-9-8

BODY - CONVERTIBLE TOP BOOT FIT

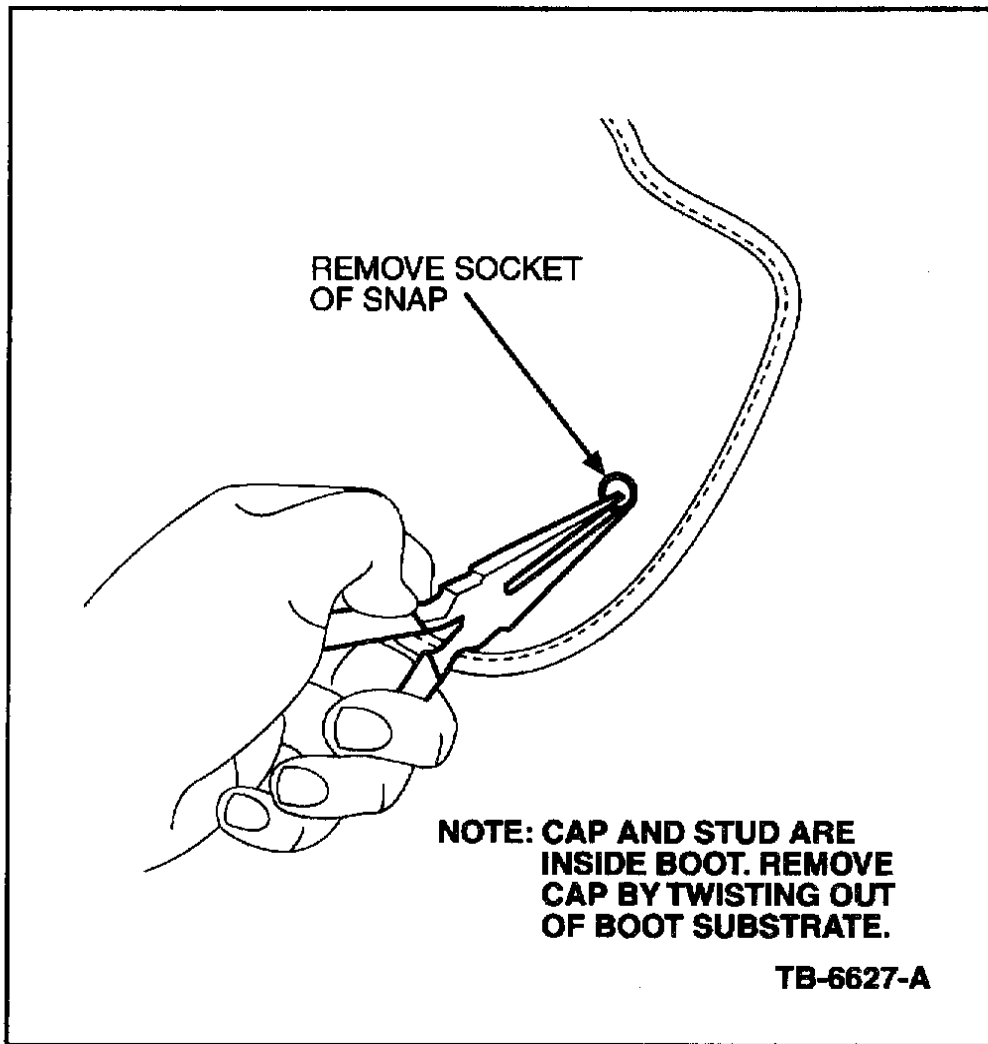
Figure 1

Some Mustang convertible vehicles may exhibit difficulty in securing the convertible top boot (cover), which may result in a poor fit. This may be caused by the snaps not holding the boot securely in place.

1. Using a pair of pliers, remove the socket of the snap, located on the convertible boot (Figure 1).
2. Remove the remaining portion of the snap, by grabbing the stud with the pliers and pulling it out of the substrate in a twisting motion.
