2001 Ford Mustang V6-3.8L VIN 4

RECALL - TUBE MOUNTED EGR PRESSURE SENSOR DEFECT

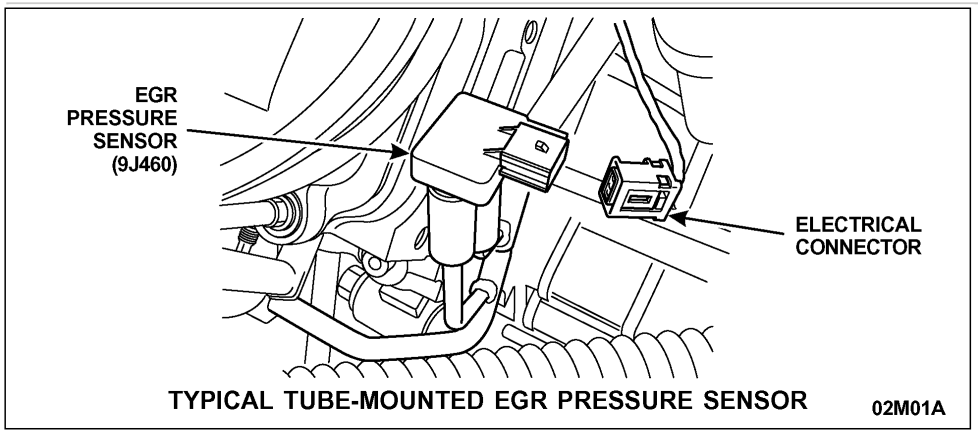
Replace the EGR pressure sensor only if one or more of the following continuous DTCs are present:

^ P1400 - DPF EGR SENSOR CIRCUIT LOW VOLTAGE DETECTED

^ P1401 - DPF EGR SENSOR CIRCUIT HIGH VOLTAGE DETECTED

^ P0401- EGR FLOW INSUFFICIENT DETECTED

^ P0402- EGR FLOW EXCESSIVE DETECTED

2. If one or more of the DTCs listed above is present, replace the EGR pressure sensor (9J460) as follows:

a) Key off.

b) Disconnect the electrical connector and remove the EGR pressure sensor from the EGR tube.

c) Install the new EGR pressure sensor onto the EGR tube and connect the electrical connector. Note: Refer to Section 303-08 of the appropriate workshop manual if additional information is required.
