2002 Ford Mustang GT V8-4.6L SOHC VIN X

ENGINE - OIL LEAK FROM R/H CYLINDER HEAD GASKET

03-6-2

ENGINE - CYLINDER HEAD DECK LEAK - 4.6 AND
5.4L ENGINES - NEW "SERVICE-ONLY" GASKET AND
CYLINDER HEAD KITS AVAILABILITY

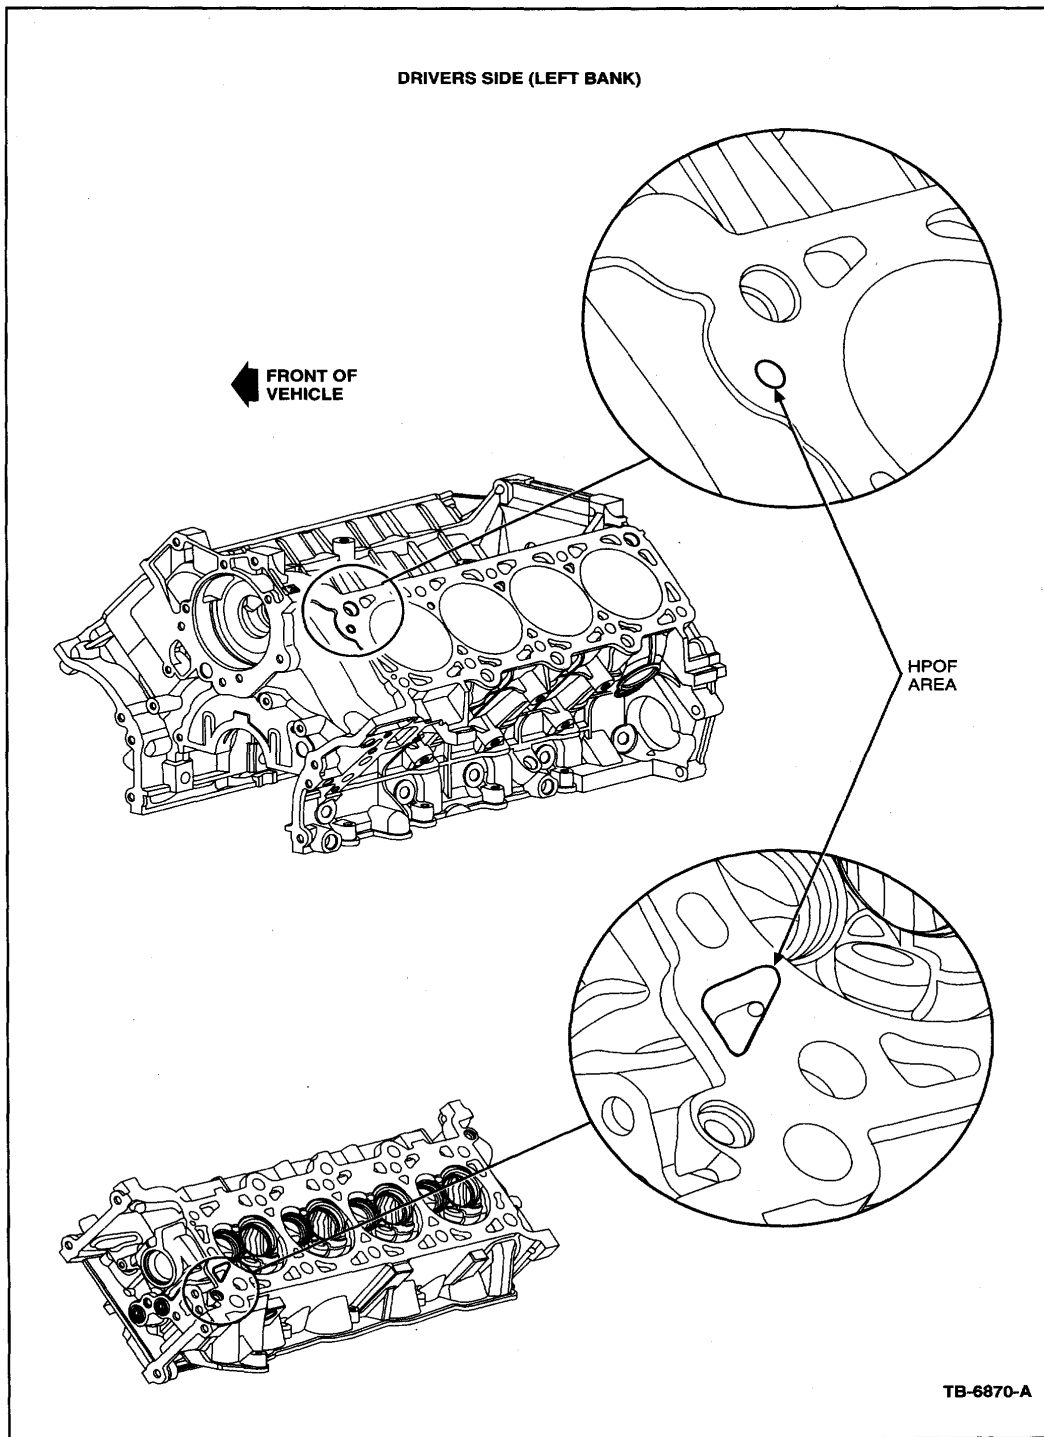
Figure 1

Cylinder heads damaged by brinnelling (depression marks from original gasket) of the head may still be reusable. The revised "Service-Only" gasket has a feature by which the embossed sealing area does not follow the same sealing path as the original gasket. This area is surrounding the High Pressure Oil Feed (HPOF) area. It is triangular in shape and is found in the rear of the passenger side cylinder head, or, in the front of the drivers side cylinder head (Figure 1 and Figure 2).
