2016 Ford Mustang V8-5.0L

SYNC 3 – NO REAR VIEW CAMERA IMAGE AT FREEZING AMBIENT TEMPERATURES - BUILT ON 01-JUL-2015 AND THROUGH 31-DEC-2016

17-2068

18 April 2017

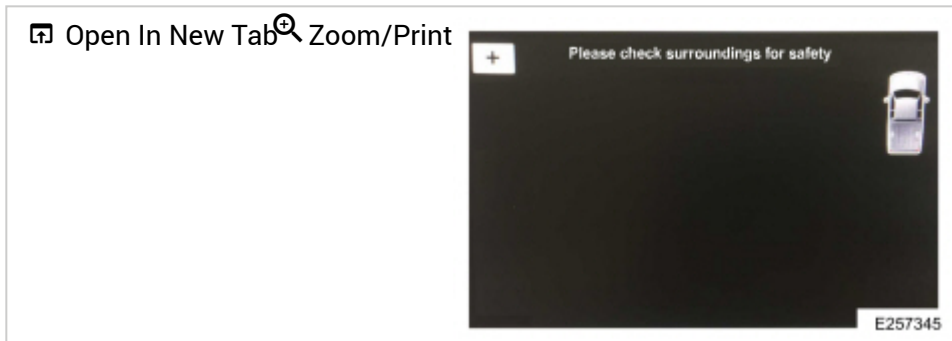
Figure 1

Issue: Some 2016-2017 Edge, Escape, Expedition, Fiesta, Flex, MKC, MKT, MKX, Mustang, Navigator, Taurus, 2017 Explorer and F-Super Duty vehicles equipped with SYNC 3 and built on 1-Jul-2015 and through 31-Dec-2016 may exhibit a SYNC display message of Please check your surroundings for safety along with no rear view camera image when in reverse gear. This will occur only at ambient temperatures ranging from -5 °C to 5 °C (23 °F to 41 °F). This maybe due to a temperature dependent issue within the APIM module.

2. Is the customer reporting a SYNC display message of Please check your surroundings for safety along with no rear view camera image when in reverse gear which occurs during an ambient temperature range of -5 °C to 5 °C (23 °F to 41 °F)? (Figure 1)

(2). No - replace the APIM. Refer to WSM, Section 415-00.
