1999 Ford Mustang GT V8-4.6L SOHC VIN X

## A/T - 4R70W TCIL/MIL ON/TROUBLE CODES STORED

99-19-7

09/20/99

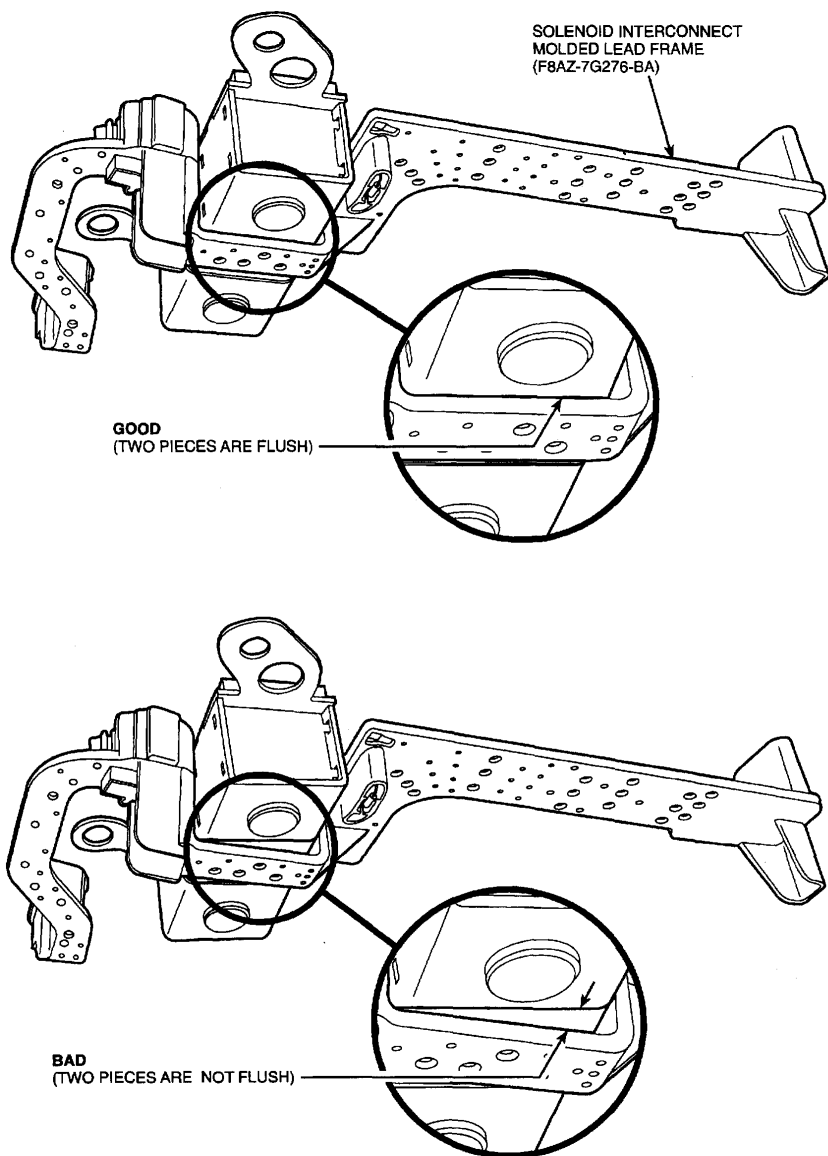
Figure 1

Intermittent Transmission Control Indicator Lamp (TCIL) or Malfunction Indicator Lamp (MIL) illumination may occur on some vehicles. The following Diagnostic Trouble Codes (DTCs) may be stored in memory: P0741, P0750, P0755, and P1746. This may be caused by the solenoid interconnect molded lead frame not being fully seated or the bulkhead interconnect clips not being fully seated between the solenoid interconnect molded lead frame and

3. Verify that the solenoid interconnect molded lead frame is fully seated on all the solenoid connectors (Figure 1). If the solenoid interconnect molded lead frame is fully seated, then gently remove the solenoid interconnect molded lead frame, valve body, and bulkhead interconnect (-7G276-) per the appropriate model Workshop Manual, Section 307-01.

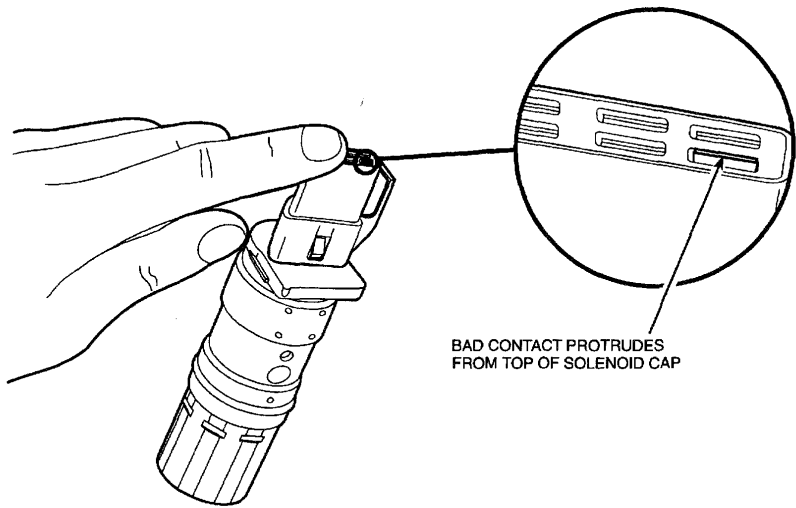
Figure 2

4. With the bulkhead interconnect removed, push down on the terminal cover and check to see if any of the terminals are slightly protruding above the plastic cover (Figure 2). Gently pry off the terminal cover using a small screwdriver (Figure 3). With the terminal cover off, inspect the bulkhead interconnect for spreading terminals (Figure 4). If the bulkhead interconnect terminals are spread or slightly protruding above the plastic cover, replace with a new Bulkhead Interconnect (F8AZ-7G276-AA).
