1999 Ford Mustang GT V8-4.6L SOHC VIN X

LEFT HAND REAR QUARTER AREA - CREAKING NOISE

99-21-8

^ BODY - "CREAKING" NOISE FROM LH REAR
QUARTER AREA - CONVERTIBLES ONLY

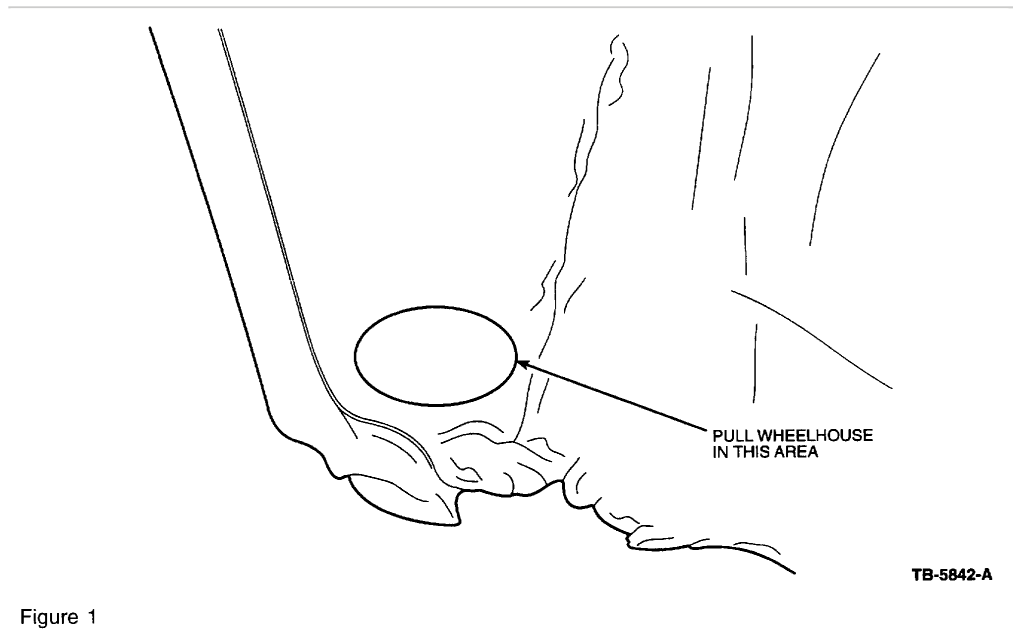
A "creaking" noise from the LH rear quarter area when going over bumps may be heard on some vehicles. This may be due to contact between the inner rocker panel and the outer wheelhouse of the LH rear quarter area.

1. Remove the left rear wheel.
2. Drill two (2) holes using a 1/8" drill bit into the wheelhouse (approximately 25 mm (1") above the lower flange and 25 mm (1") outboard of the wheelhouse seam).

3. Using a dent puller, pull the wheelhouse metal away from the rocker panel (Figure 1).
4. Redrive vehicle to make sure concern is repaired.
5. If concern is still present, repeat Steps 2-4 with two (2) more holes approximately 19 mm (3/4") outboard of the wheelhouse seam. Do not drill more than a total of four (4) holes.
6. Spray over the holes with Super Seal Anti-Corrosion Compound (F3AZ-19515-SA or equivalent meeting Ford Specification ESR-M7C54-A).
