1999 Ford Mustang GT V8-4.6L SOHC VIN X

CONVERTIBLE TOP BOOT - IMPROPER FIT

99-22-5

CONVERTIBLE TOP - IMPROPER FIT OF CONVERTIBLE TOP BOOT

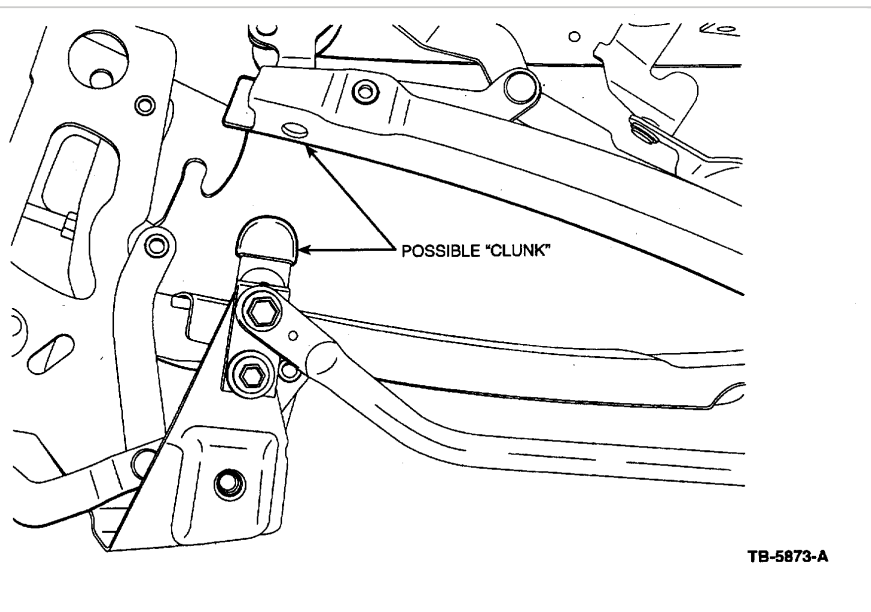
Figure 1

The convertible top boot may fit improperly or be difficult to install on some vehicles due to the top not folding down all the way into the well.

2. Cycle top to closed position for easiest access to main pivot bracket and downstop bolt (Figure 1).
3. Adjust downstop bolt clockwise with a 13 mm deep well socket to lower the convertible top downstack height.

TYPICALLY ONE TO TWO TURNS WILL BE SUFFICIENT ADJUSTMENT.
