1999 Ford Mustang GT V8-4.6L SOHC VIN X

DRIVER'S FOOTWELL AREA - POPPING/OIL CANNING NOISE

99-22-6

NOISE - "POPPING" OR "OIL CANNING" NOISE
FROM DRIVER'S FOOTWELL AREA

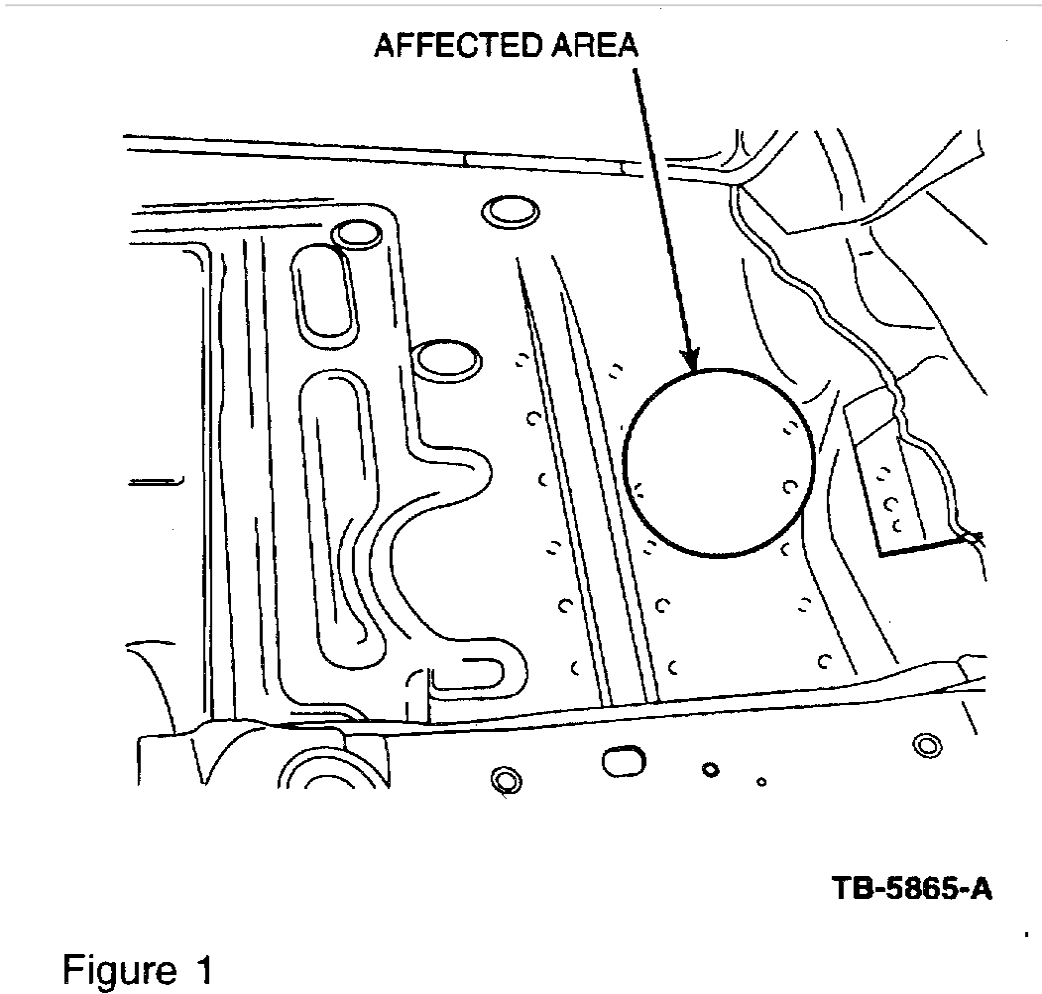
A "popping" or "oil canning" noise may be coming from the driver's footwell area, approximately 152-203 mm (6-8") rearward of where the driver's heel would rest when operating the accelerator pedal.

2. Pull back the carpet covering the affected area. Refer to Figure 1 for approximate location.
