1999 Ford Mustang GT V8-4.6L SOHC VIN X

A/T - COLD FLUID LEVEL CHECKING

99-5-3

TRANSMISSION - CHECKING TRANSMISSION FLUID
LEVEL COLD - SERVICE TIP

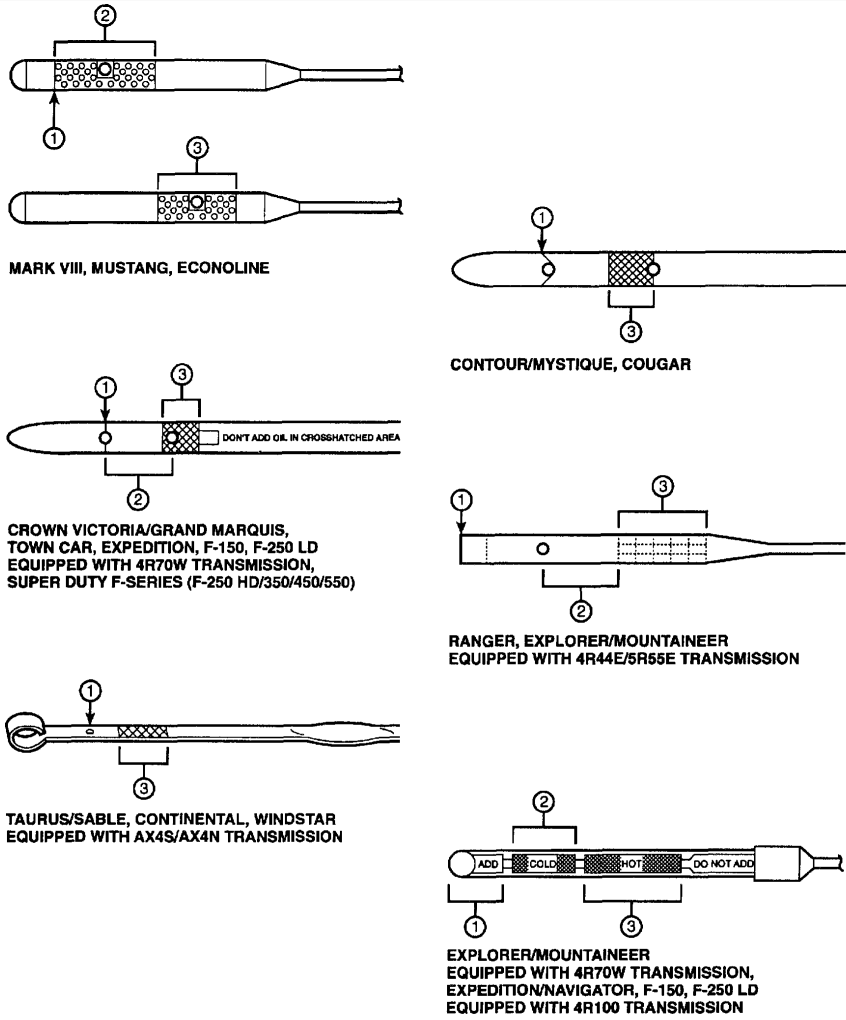
Figure 1

Some vehicles equipped with an automatic transmission/transaxle are being overfilled with transmission fluid after repairs and during the pre-delivery inspection. Over-filling the transmission/transaxle with transmission fluid may cause transmission shift concerns and/or internal transmission/transaxle damage. The 1999 Pre-Delivery Inspection (PDI) Manual is being revised for clarity.

ITEM	DESCRIPTION
1	DO NOT DRIVE MARK
2	FLUID LEVEL AT ROOM TEMPERATURE 10-35°C (50-95°F)
3	FLUID LEVEL AT OPERATING TEMPERATURE 66-77°C (150-170°F)

The appropriate year Workshop Manual contains the proper transmission fluid checking and adding procedure specific to each vehicle model. Prior to the update of the Pre-Delivery Inspection Manual, refer to the appropriate model year Workshop Manual by vehicle line for the proper information on checking and adding transmission fluid. Dipstick application is model dependent (Figure 1).

TRANSMISSION FLUID LEVEL ON THE DIPSTICK CHANGES AS THE FLUID ACHIEVES NORMAL OPERATING TEMPERATURE. TRANSMISSION FLUID EXPANDS AS TEMPERATURE INCREASES. DURING PRE-DELIVERY INSPECTION, DO NOT ADD/REMOVE TRANSMISSION FLUID WHEN THE FLUID TEMPERATURE IS BELOW NORMAL OPERATING TEMPERATURE (BETWEEN 66-77°C (150-170° F)).
