SSM # 21-0616-AA

2020-2021 Roush RS3 Front Fender Canard Rubbing

2020-2021 Roush RS3 Equipped with Magneride Suspension

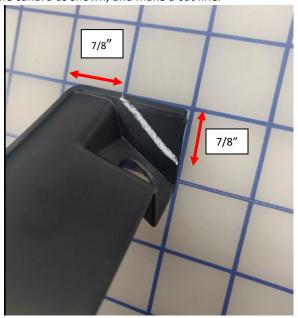
Some customers may experience rubbing of the front tires on the inside of the canard. This happens during aggressive maneuvering or harsh roads which may cause the tire to hit slighly on the front wheel canards.

2. Measure on the TOP of the canard as shown, and make a cut line.
