TECHNICAL SERVICE BULLETIN

Whistle Noise From Center Of Vehicle And/Or Climate Control Housing - Built On Or Before 24-Aug-2021

21-2352

Ford
2021 Bronco

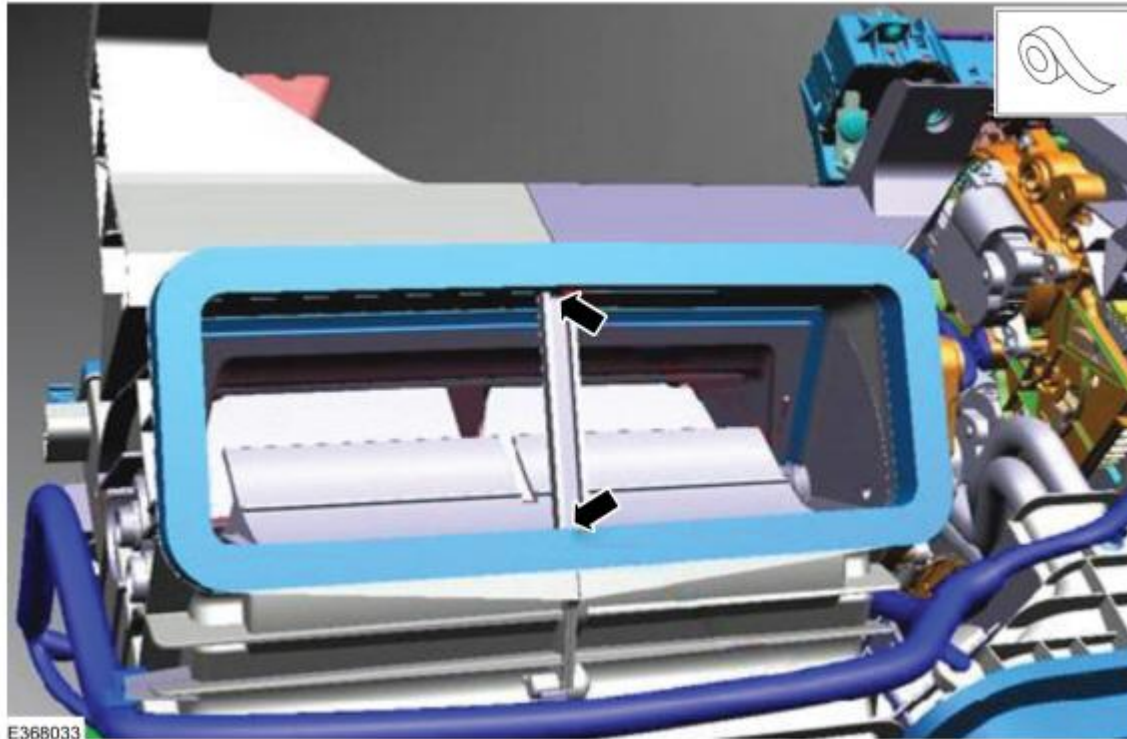
Figure 1

Issue: Some 2021 Bronco vehicles built on or before 24-Aug-2021 may exhibit a whistle noise coming from the front center of the vehicle and/or the climate control housing. This may be due to the sealing on the climate control case. To correct the condition, follow the Service Procedure to apply butyl tape to cover small holes in the fresh air inlet door.

1. Open a front side window and cycle the heating, ventilation, and air conditioning (HVAC) control module recirculation mode to the ON and OFF setting while driving above 40 mph (64 km/h).
 2. Is a whistle noise heard with the HVAC control module recirculation setting in the ON position?
 - (1). Yes - proceed to Step 3.
 - (2). No - this article does not apply. Refer to Workshop Manual (WSM), Section 412-00.
 3. Turn off the HVAC control module recirculation mode.
 4. Remove the cowl panel grille. Refer to WSM, Section 501-02 Front End Body Parts > Removal and Installation > Cowl Panel Grille.
 5. Apply butyl tape over the 2 small holes on the top and bottom section of the fresh air inlet door of the climate control housing. (Figure 1)
- NOTE: This may be a blind operation and the fresh air inlet door needs to be in fresh air mode so it remains out of the way.**

6. Inspect the area the butyl tape was installed for correct location. Apply more tape if required.
 7. Reinstall the cowl panel grille. Refer to WSM, Section 501-02 Front End Body Parts > Removal and Installation > Cowl Panel Grille.
-
