# TECHNICAL SERVICE BULLETIN

## Soft Top Roof - Loose Exterior Fabric On Rear Window

**22-2055**  
21 February 2022

Ford 2021-2022 Bronco	Soft top roof
--------------------------	---------------

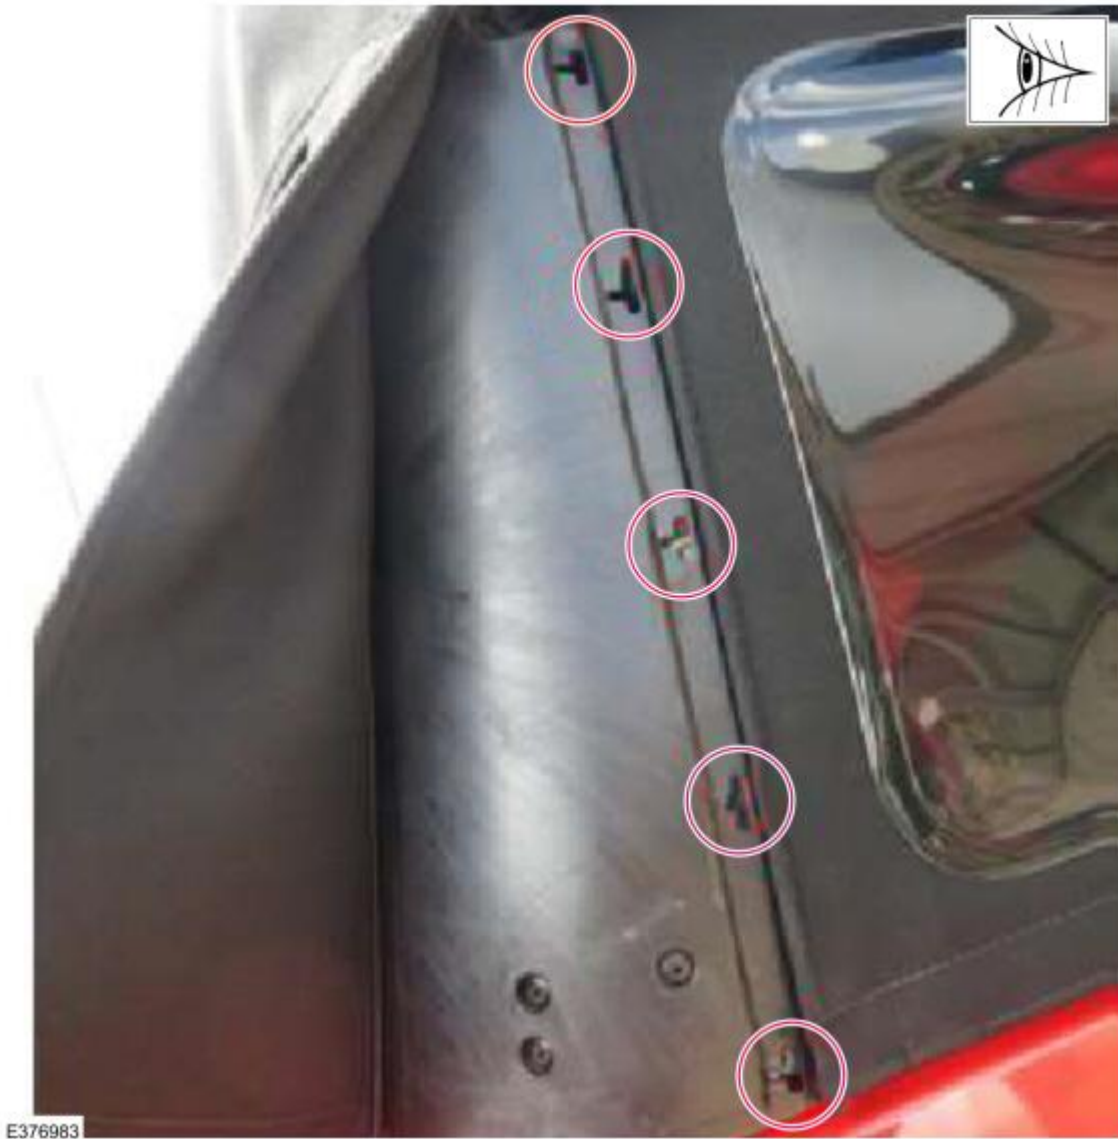
Figure 1 - Right D-pillar shown, left side similar

1. Visually inspect the 5 clips that run vertically along each D-pillar on the rear window (Figure 1)

2. Are any of these clips broken causing the rear window fabric to become loose?
