# TECHNICAL SERVICE BULLETIN

## 5 Door - Hard Top - Poor Sirius XM® Satellite Radio Reception And/Or Signal Loss - Built On Or Before 17-May-2022

**22-2096**

<b>Ford</b> 2021-2022 Bronco
---------------------------------

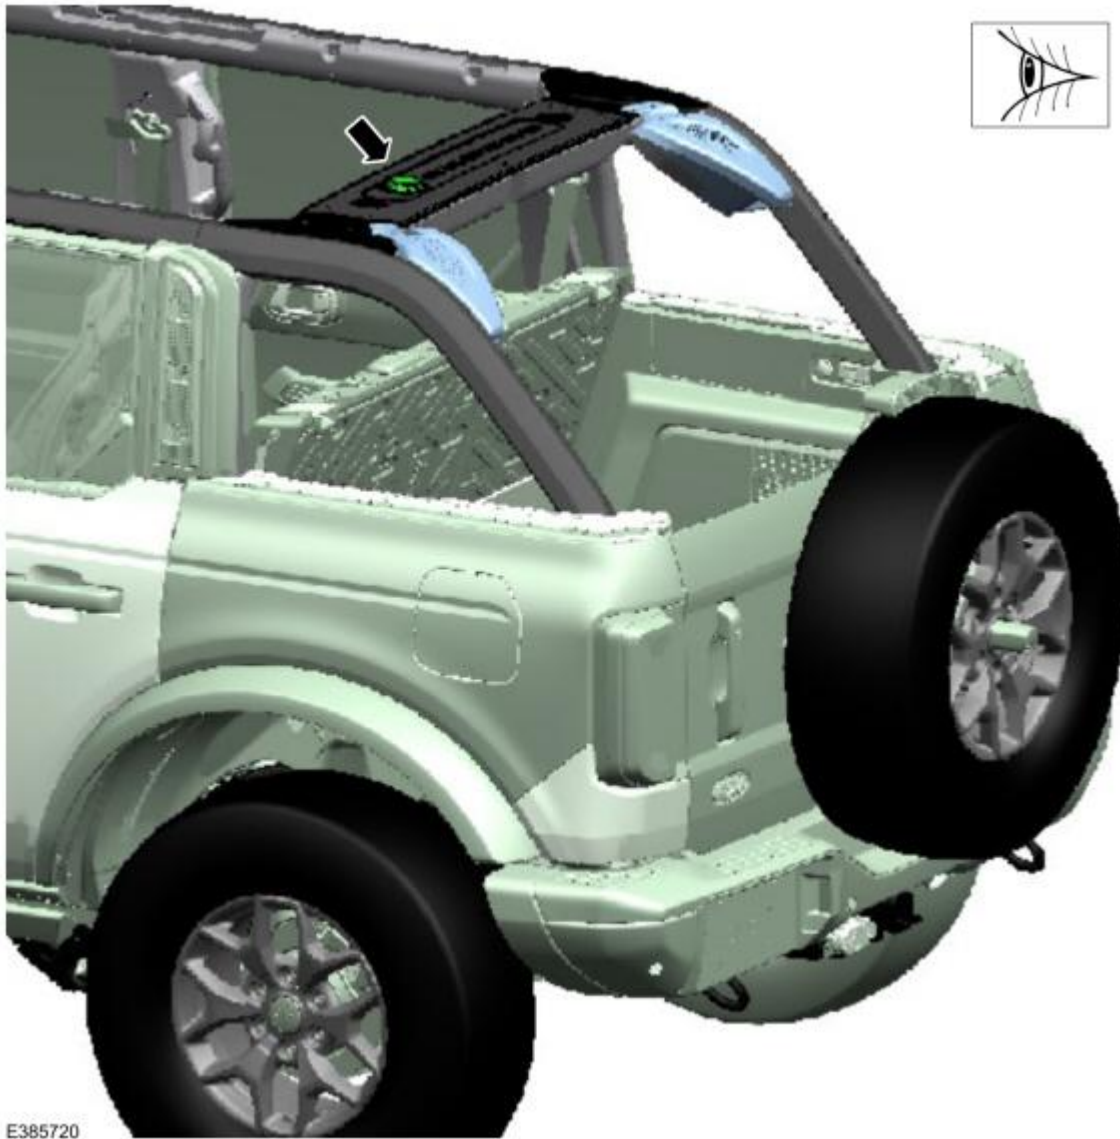
Figure 1

2. Locate the satellite radio/global positioning system (GPS) antenna on the rear overhead cross tube of the sport tube. It is mounted on the top of the sport tube between it and the hard top. (Figure 1)

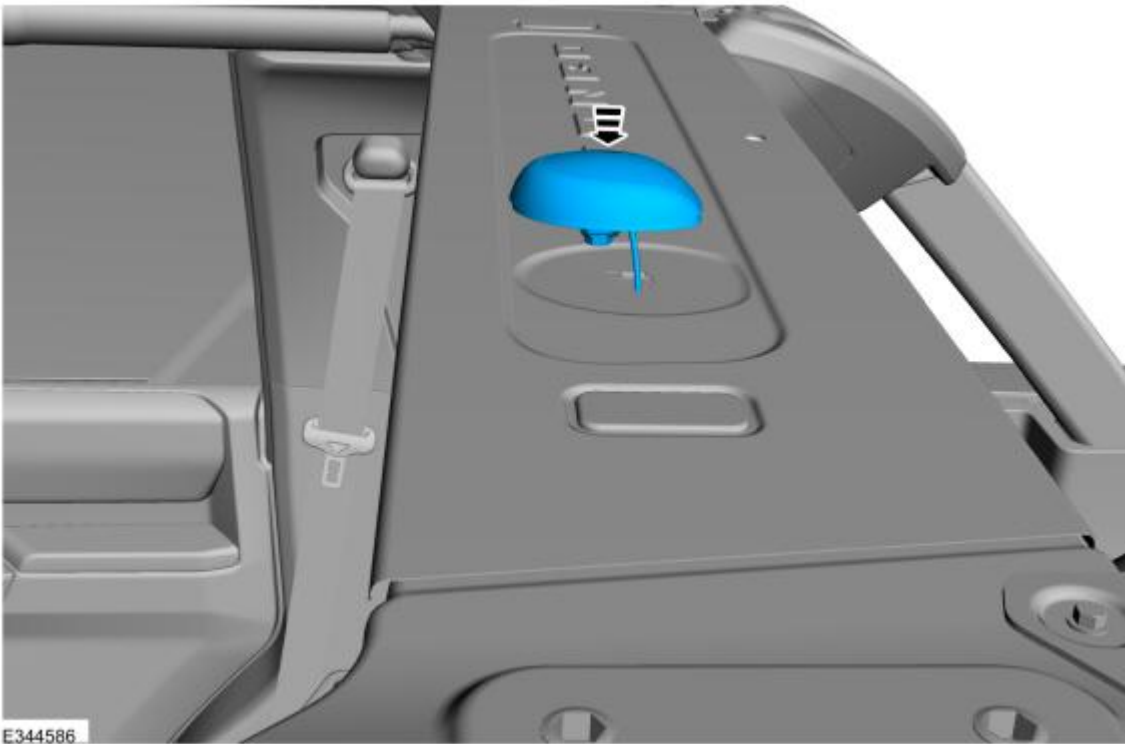
Figure 2

3. Inspect the position of the satellite radio/GPS antenna. Does the base of the antenna match the depression/outline in the sheet metal? (Figure 2)

(1). Yes - proceed to Step 4.

(2). No - this article does not apply. Refer to WSM, Section 415-00.
