TECHNICAL SERVICE BULLETIN

5 Door - Hard Top Roof - Squeak And/Or Chirp From Rear Of Vehicle

22-2097

Ford	5 door
2021-2022 Bronco	Hard top roof

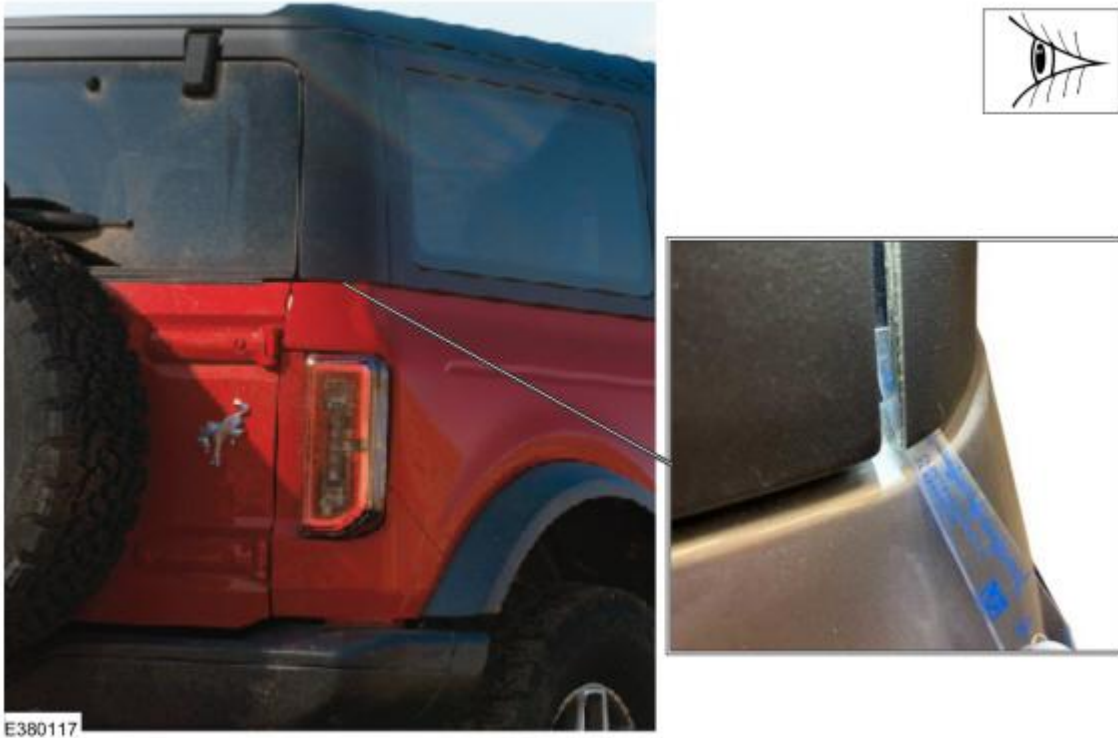
Figure 1

Issue: Some 2021-2022 Bronco vehicles equipped with 5 doors and a hard top roof may experience a squeak and/or chirp noise from the rear of the vehicle while driving over bumps with the roof installed. This may be due to an insufficient gap between the hard top and the body rear quarter panel. To correct the condition, follow the Service Procedure to adjust this gap to the correct specifications.

1. Insert a 3/64 in. (1 mm) plastic feeler gauge in the gap between the bottom/rear corner of the hard top and the rear quarter panel until the gauge is 2 in. (50 mm) deep. (Figure 1)

10. Use a plastic feeler gauge to measure the gap between the bottom/rear corner of the hard top and the rear quarter panel. (Figure 1)
11. Does the gap measure between $3/32$ - $7/32$ in (2.5 - 5.5 mm)?

14. Use a plastic feeler gauge to measure the gap between the bottom/rear corner of the hard top and the rear quarter panel. (Figure 1)
15. Does the gap measure between $3/32$ - $7/32$ in (2.5 - 5.5 mm)?
