TECHNICAL SERVICE BULLETIN

Seat Pan Looseness, Lateral Movement, Or Clunk/Thump Noise On Turns

22-2104

18 March
2022

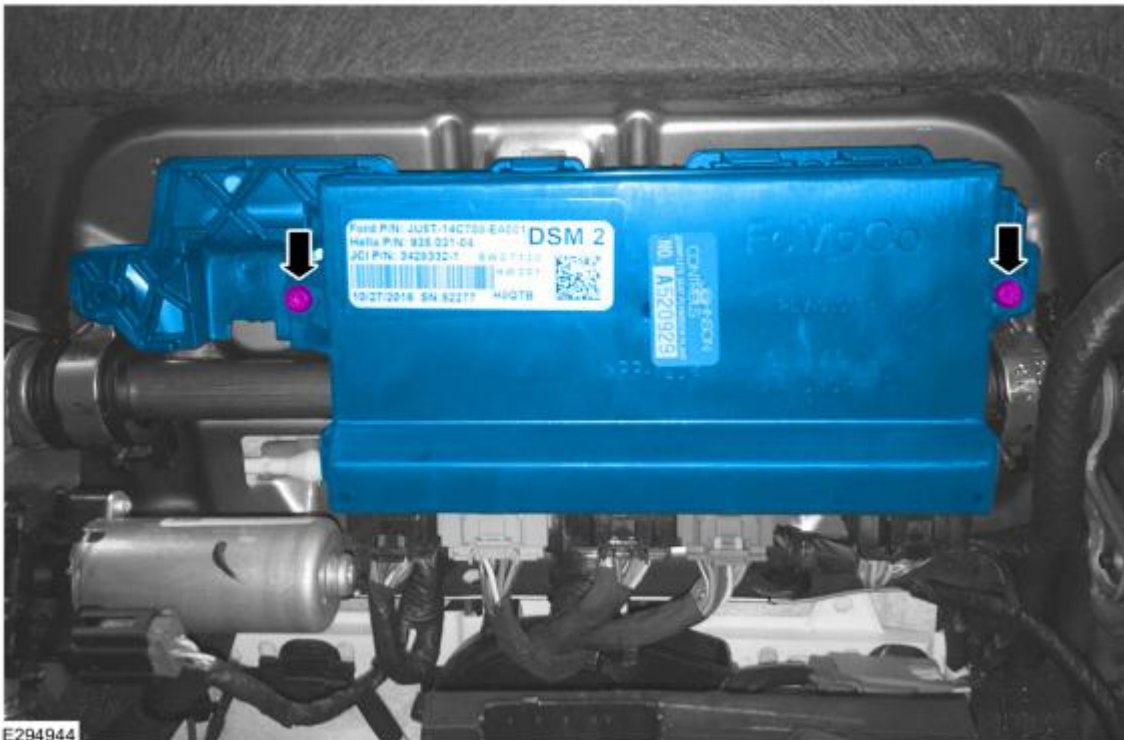
Figure 1

4. Is the vehicle equipped with a power seat control module under the seat? (Figure 1)

(1). Yes - remove the 2 power seat control module retaining screws and remove the power seat control module.
