TECHNICAL SERVICE BULLETIN

Hard Top Roof - Front Roof Panels - Uneven Height Causing Poor Appearance, Excessive Wind Noise, Water Leaks And/Or Difficulty Latching

22-2288

Ford 2021-2022 Bronco	Hard top roof
---------------------------------	---------------

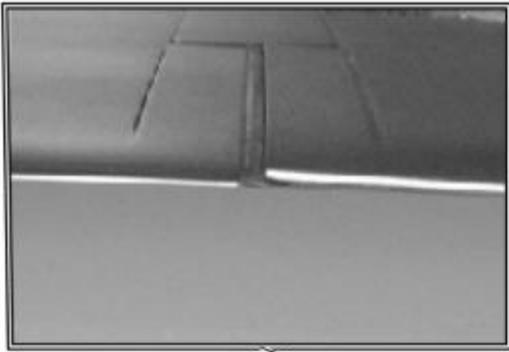
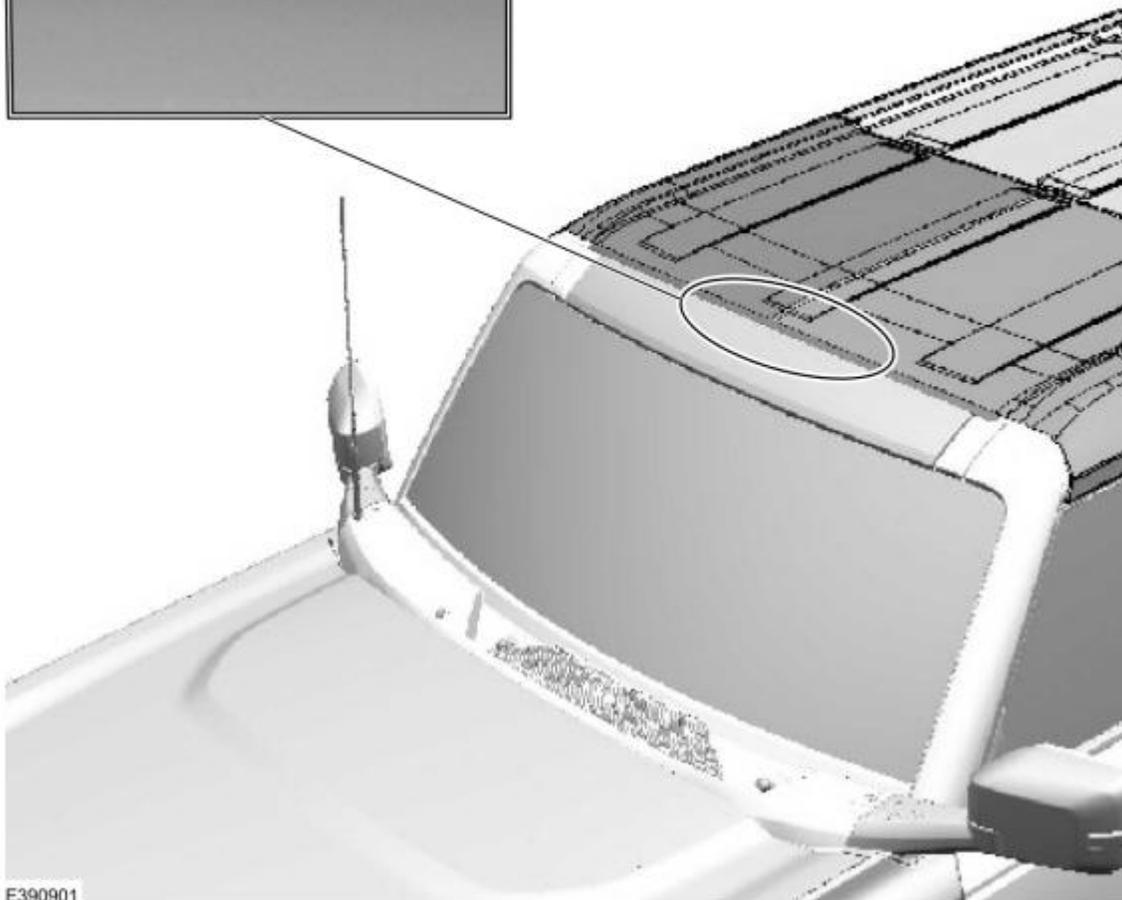
Figure 1

Issue: Some 2021-2022 Bronco vehicles equipped with a hard top roof may exhibit symptoms from the front roof panels that sit at an uneven height which may result in a poor appearance, excessive wind noise, water leaks and/or difficulty latching. This may be due to incorrect vertical adjustment of the front roof panel latch strikers. To correct this condition, follow the Service Procedure to adjust the front panel latch strikers.

1. Do the front roof panels sit at an uneven height? (Figure 1)

- (1). Yes - proceed to Step 2.
- (2). No - this article does not apply.
2. Remove the windshield header trim panel. Refer to Workshop Manual (WSM), Section 501-05.
3. Locate the front center strikers, just above the rear-view mirror. Using a marker, outline the mounted position of both strikers on the body. These marks may be used to return the strikers to their original position or to show how much adjustments were made when the repair is complete. (Figure 2)

6. Adjust the position of the strikers as needed to obtain a flush appearance between the 2 front roof panels. It may be necessary to hand tighten the striker bolts to hold them in place during inspections. Once flushness is achieved, test the roof latching effort to be sure it is not excessive.

7. Once correct striker placement and latching effort is achieved, tighten the front striker bolts to 20 Nm (15 lb-ft).
8. Install the windshield header trim panel. Refer to WSM, Section 501-05.
