# TECHNICAL SERVICE BULLETIN

## Water Leak Onto Front Carpet From A-Pillar

**22-2242**

Ford 2015-2022 Mustang
---------------------------

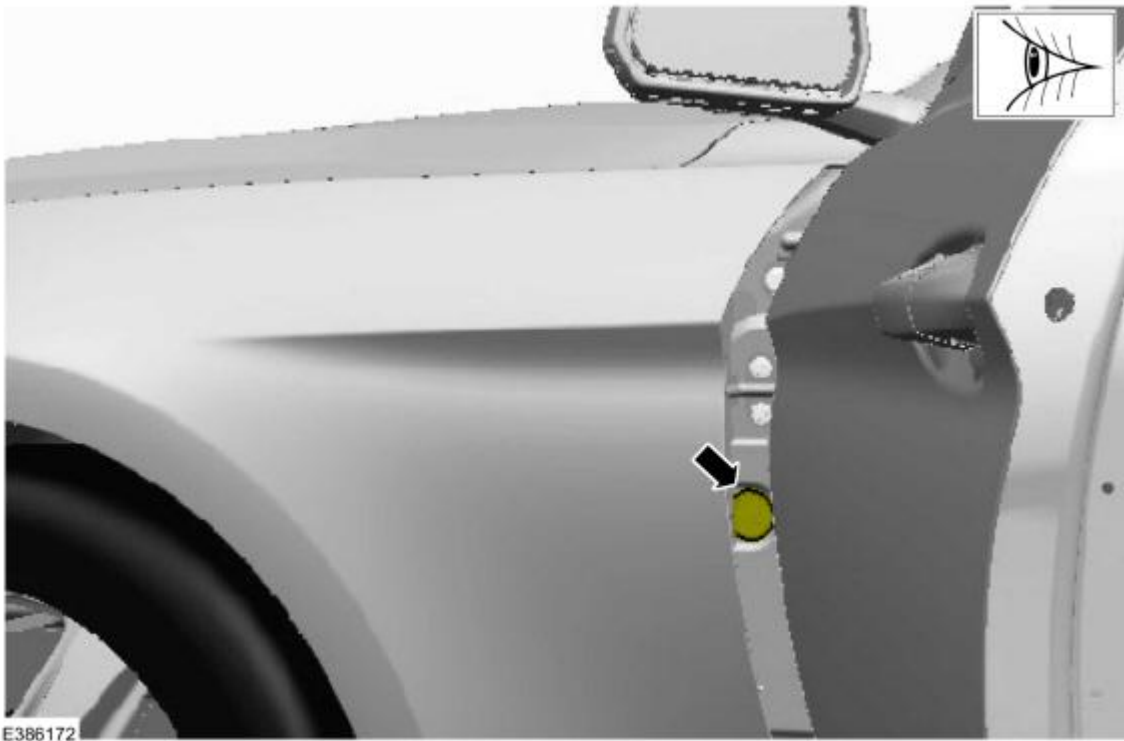
1. Fully open both doors.
2. Inspect the body seals on both A-pillars for complete 360-degree adhesion to the sheet metal. (Figure 1)

**NOTE: The A-pillar body seals are an adhesive patch that seals a 19 mm (0.75 in.) diameter hole in the sheet metal. These seals must have complete adhesion around all edges. If any portion of the sealing surface is compromised, water entry into the cabin may result.**

Figure 1 - Left A-pillar shown, right A-pillar similar

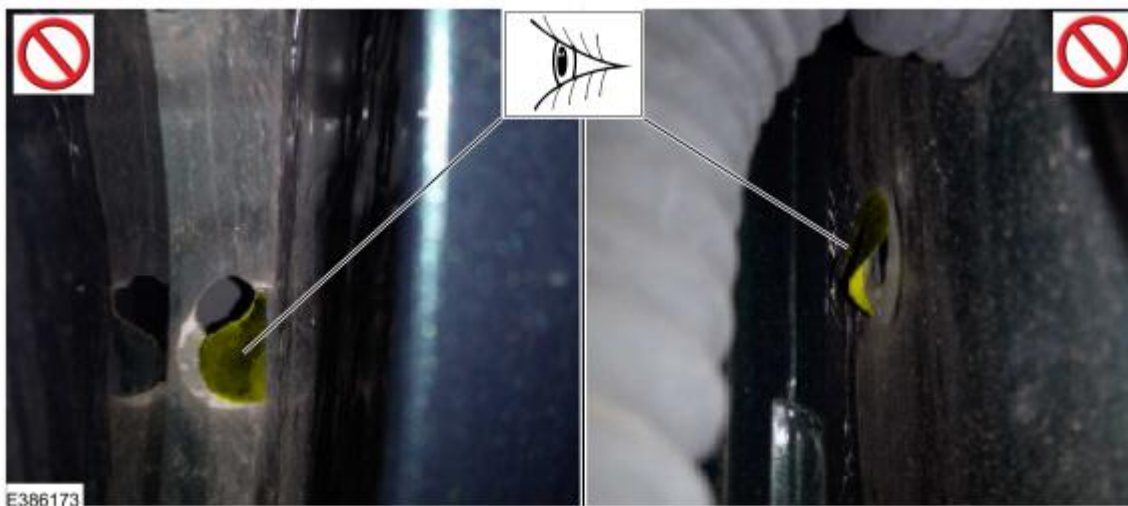
3. Are the body seals on both A-pillars completely sealed to the body? (Figure 2)

Figure 2 - Example of failed A-pillar sticker seals

- (1). Yes - this article does not apply.
  - (2). No - proceed to Step 4.
4. Inspect the fender insulator to be sure it does not restrict access to the A-pillar body seal. If the fender insulator covers any portion of the A-pillar body seal, the foam fender insulator can be slightly indented to allow for unobstructed access to the seal.
  5. Apply paint-safe, protective tape to the door and fender edges.
  6. Use fingers and/or pliers to completely remove and discard the A-pillar body seal.

7. Use alcohol wipes to remove all remaining adhesive left by the discarded body seal.
8. Apply Motorcraft® Anti-Corrosion Coating to all exposed metal around the A-pillar body hole. Allow the Motorcraft® Anti-Corrosion Coating to dry following the instructions on the container.
9. Use a small paint brush to apply touch-up paint to the exterior surfaces that were previously coated with Motorcraft® Anti-Corrosion Coating. Allow paint time to dry following the instructions on the touch-up paint container.
10. Install and fully seat the new rubber body plug into the A-pillar body hole.
11. If the other A-pillar body seal requires repair, repeat Steps 4-10.
