**FORD:**  
2005 Mustang

This article supersedes TSB **05-17-14** to update the Service Procedure.

# TSB 05-19-10 (Continued)

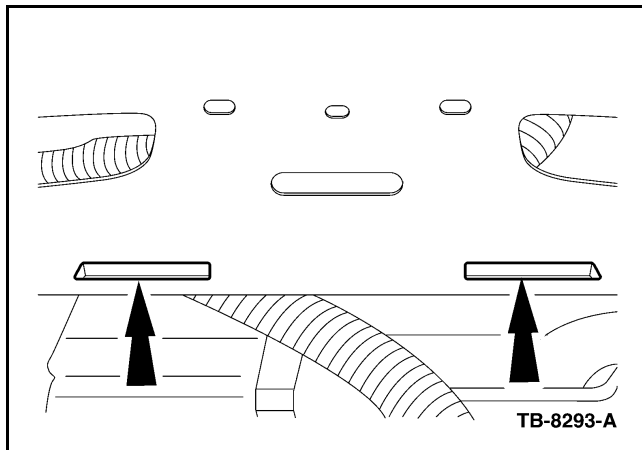
Figure 1 - Article 05-19-10

Some 2005 Mustangs built before 5/10/2005 may exhibit the seat cushion cover front trim being loose on the front seat. The J-clip that holds the seat cushion cover trim to the front of the seat pan may not be fully engaging the flanges (slots) in the seat pan.

1. Pull back the seat cushion cover trim and foam to access the (4) flanges in the seat pan (Figure 1).
