2005-2006 Mustang  
2006 Explorer  
2007 Explorer Sport Trac

2006 Mountaineer

Some 2005-2006 Mustang GT, 2006 Explorer 4dr/Mountaineer and 2007 Explorer Sport Trac vehicles may exhibit the malfunction indicator lamp (MIL) on, with diagnostic trouble codes (DTCs) P2004 through P2008, P151A, P2015, and P2020. All of these codes are associated with the charge motion control valve (CMCV), actuator motor, and/or linkage concerns.

# TSB 06-7-10 (Continued)

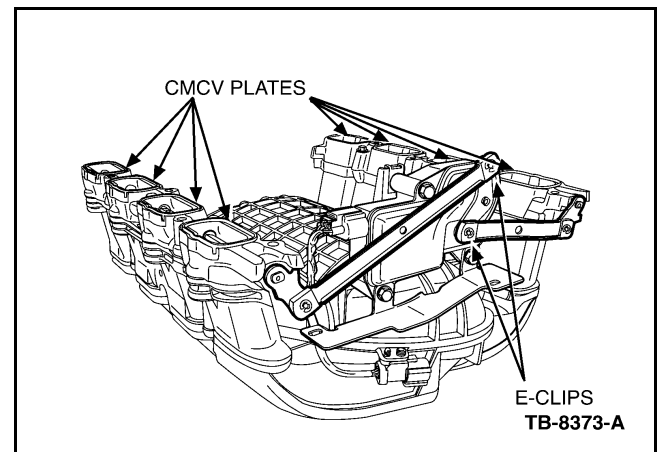
Figure 1 - Article 06-7-10

3. Disconnect the CMCV linkages from actuator motor by removing the two (2) clips (Figure 1). Discard clips.

4. Rotate each CMCV shaft (right hand and left hand) by hand, to verify that the system does not stick or bind. The shafts should rotate freely and any sticking or binding will require replacement of the entire intake manifold.
5. If the components inspected in Steps 1, 2, and 3 are OK, then replace CMCV actuator motor by following procedure included in the service kit.
