FORD:
2005-2008 Mustang

TSB 07-16-7 (Continued)

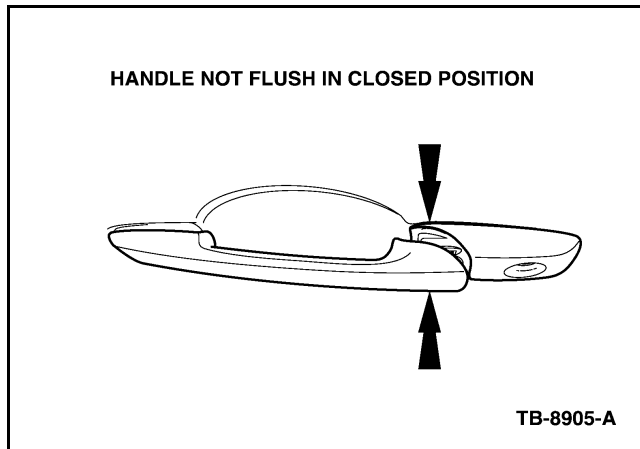
Figure 1 - Article 07-16-7

Some 2005-2008 Mustang vehicles may exhibit an exterior door handle not flush in the closed position. This may result in a loose handle, rattle noise, hard to open, and/or door self locks when opening outside handle. (Figure 1)

The concern is caused by pre-loading/biasing the exterior door handle actuating rod, the front door latch, or both. Follow the Service Procedure steps to correct the condition.
