FORD:
2005-2008 Mustang

This article supersedes TSB **05-24-6** to update the vehicle model years and Part List.

TSB 07-17-8 (Continued)

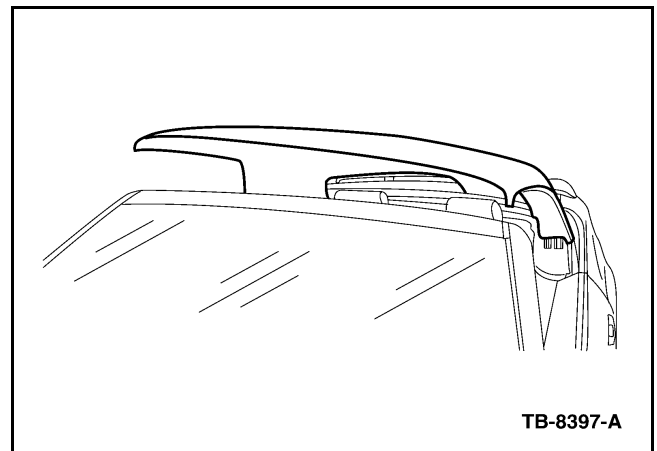
Figure 1 - Article 07-17-8

1. Top lifts unevenly side-to-side with no hydraulic system issues. (Figure 1)

Replace Side Rails:

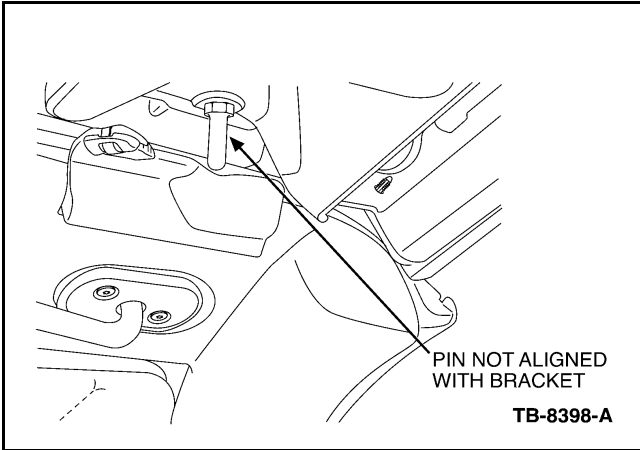
Figure 2 - Article 07-17-8

2. Top latch dowel pins do not align with header latch bracket. (Figure 2)

IF THE LATCH DOWEL PINS ALIGN WITH THE LATCH BRACKET, BUT ARE TOO FAR FROM THE WINDSHIELD HEADER TO CLOSE EASILY, THEN TRY RELAXING THE MATERIAL PRIOR TO REPLACING ANYTHING. TO RELAX THE MATERIAL, CLOSE AND LATCH THE TOP, AND PUT VEHICLE IN PAINT BOOTH OVEN WITH HEAT ON FOR A COUPLE HOURS.

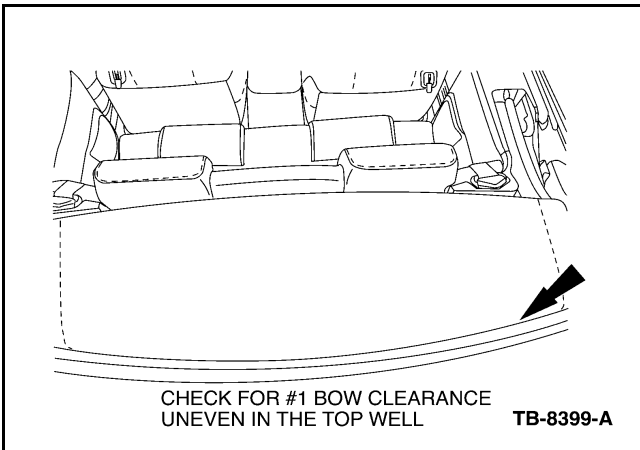
Figure 3 - Article 07-17-8

3. Top number 1 bow clearance to top well in the body is uneven. (Figure 3)

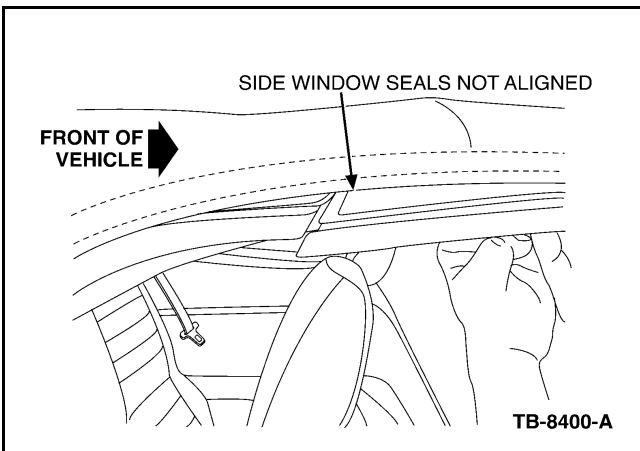
Figure 4 - Article 07-17-8

4. Side window seals do not align properly to side glass. (Figure 4)

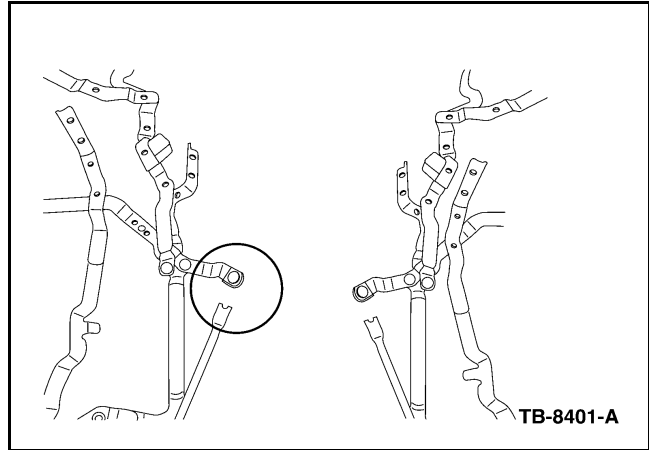
Figure 5 - Article 07-17-8

1. Side rail linkage broken. (Figures 5 and 6)

Replace Top Assembly:
