FORD:
2005-2009 Mustang

TSB 08-17-3 (Continued)

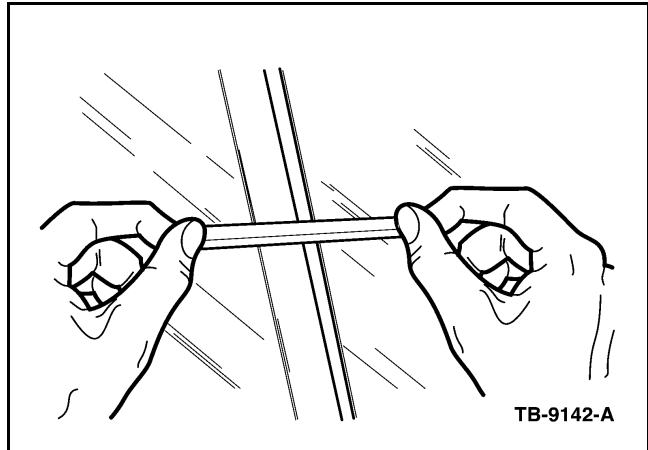
Figure 6 - Article 08-17-3

MISALIGNED DOOR GLASS WILL BOUNCE BACK DURING OPERATION IF IT CONTACTS THE INBOARD SIDE OF THE UPPER CONVERTIBLE SEAL RETAINER. CONCERN MAY BE DUPLICATED WITH TOP UP AND REAR WINDOWS DOWN. DOOR GLASS MUST BE ALIGNED TO BOTH THE CONVERTIBLE TOP AND QUARTER GLASS DIVISION BAR.

5. Adjust the door glass so that the door glass is flush to the quarter glass division bar or outboard of the division bar by no more than 1/16" (2 mm). (Figure 6). Use the door glass window regulator jack screw to adjust glass outboard. Remove the round reflector located at the bottom of the door trim panel. Turning the jack screw clockwise tips the glass outboard, counterclockwise tips the glass inboard. If additional adjustment is needed, then remove trim panel and use glass clamps. Refer to WSM, Section 501-11.
