**DOOR MOUNTED SUBWOOFER—STATIC, CRACKLE,
POP OR DISTORTED SOUND—BUILT BEFORE
7/7/2008**

TSB 08-20-2

FORD:
2008-2009 Mustang

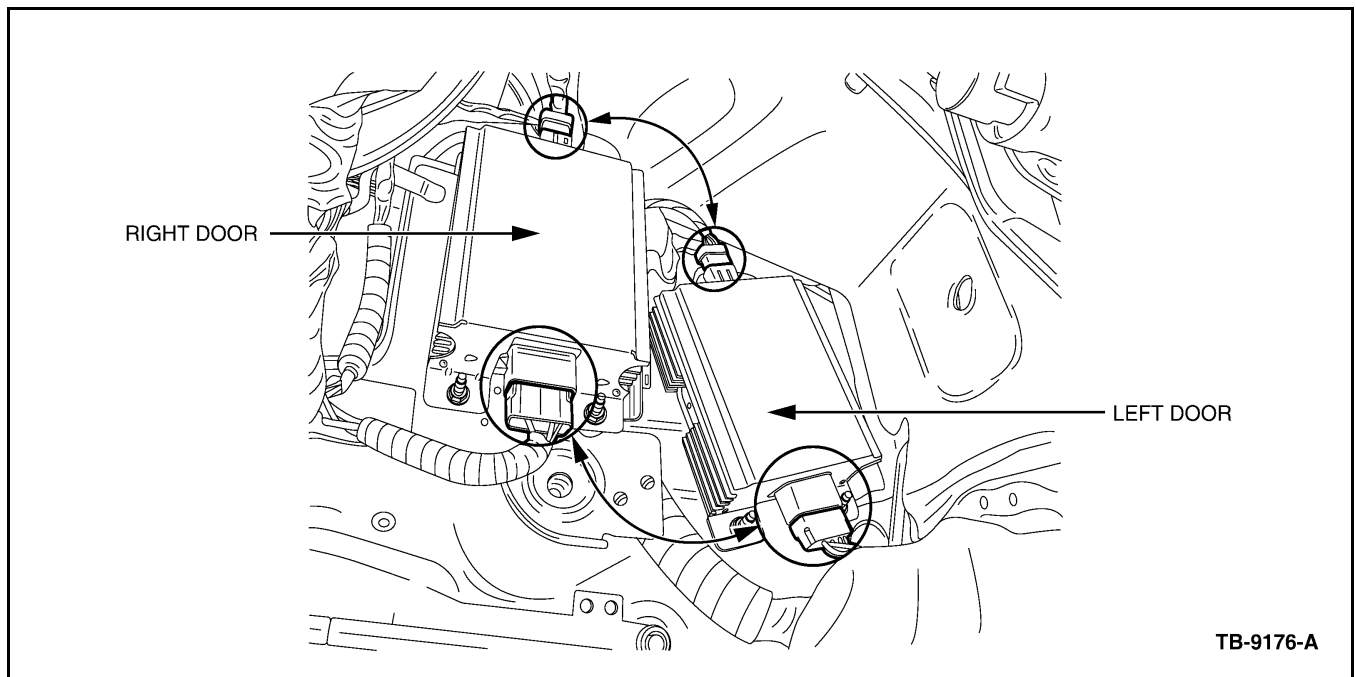
Figure 1 - Article 08-20-2

The vehicle is equipped with two (2) subwoofer amplifiers which are located next to each other under the driver's side kick panel.

Swap the upper and lower connectors, from one amplifier to the other, and confirm that the crackle follows the amplifier to isolate the bad part. (Figure 1)

Replace the suspect amplifier per Workshop Manual, Section 415-00. If static cannot be isolated then continue with normal diagnostics per Workshop Manual, Section 415-00.
