FORD:

2005-2009 Mustang

TSB 08-24-10 (Continued)

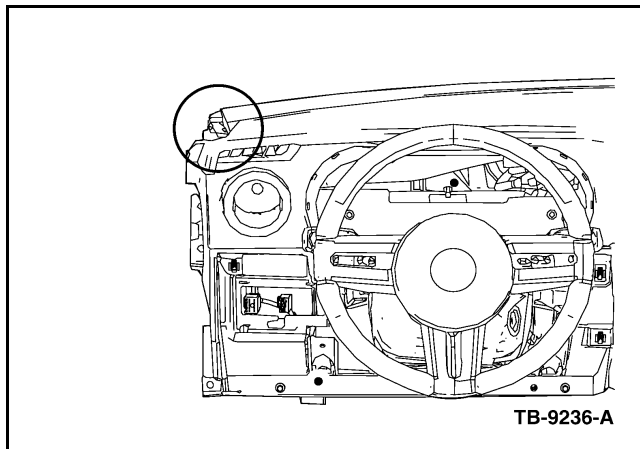
Figure 1 - Article 08-24-10

Some 2005-2009 Mustang vehicles may exhibit a rattle noise where the A-pillar meets the dash area. This rattle may be due to worn, missing or off location tape under the dash panel and/or A-pillar dual lock (velcro) fastener(s) not seated.

DASH INSULATOR WAS EXTENDED UNDER THIS AREA FOR 2008 AND 2009 VEHICLES. (FIGURE 1) FOR 2005-2007 VEHICLES MULTIPLE VARIETIES OF TAPE WERE USED UNDER THIS AREA. (FIGURE 2)

1. Remove A-pillar trim.
2. Inspect for tape under flanged edge of dash panel. If tape is missing or damaged, then add or replace with improved tape. This tape has a plastic top coating to protect the felt tape from wear. Install felt tape with adhesive side down. (Figures 1-2)
