## 4.0L ENGINE BELT SQUEAL OR CHIRP NOISE ON COLD STARTUP

TSB 09-7-7

### FORD:

2009 Mustang  
2007-2008 Explorer Sport Trac, Explorer

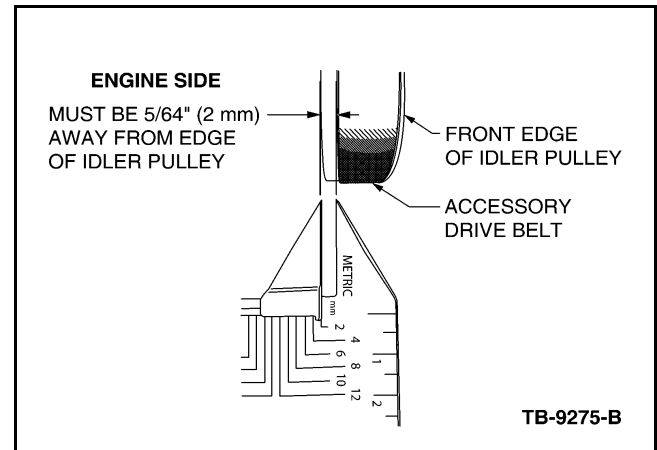
Figure 1 - Article 09-7-7

1. Visually inspect all related FEAD components for damage and or abnormal wear. Reference the online Work Shop Manual (WSM), Section 303-05. If no concerns found, proceed to Step 2.
2. Inspect for FEAD belt clearance on the idler pulley. A properly aligned belt will have an approximate  $3/32''$  (2 mm) space behind the belt on the idler pulley. (Figure 1)
3. Verify the generator bracket and idler pulley are properly seated and torqued to specification. Reference the online (WSM), Section 303-05.
  - a. If there is not an approximate  $3/32''$  (2 mm) gap, proceed with Step 3.
  - b. If there is an approximate  $3/32''$  (2 mm) gap, proceed with Step 5.
4. Replace the generator bracket with updated bracket. Reference online (WSM), Section 303-01. Proceed to Step 5.

- 5. Replace the accessory drive belt with the updated belt part number. Reference online (WSM), Section 303-05.
