TICK/POP/SNAPPING/BUZZ NOISE FROM DOOR PANEL WHEN OPERATING AUDIO SYSTEM— VEHICLES BUILT BEFORE 5/1/2009

TSB 09-12-7

FORD:
2010 Mustang

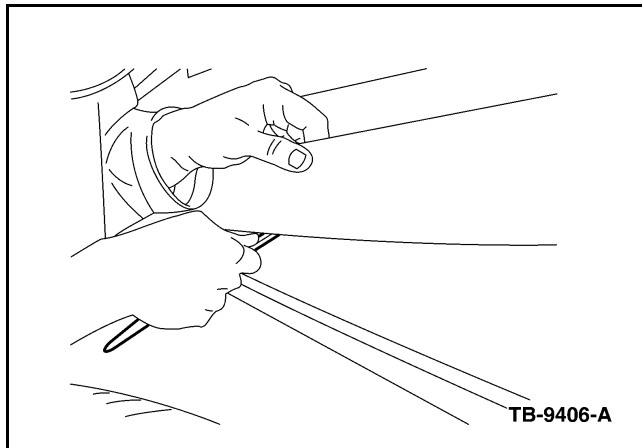
Figure 1 - Article 09-12-7

Some 2010 Mustang vehicles built before 5/1/2009 may exhibit a tick/pop/snapping/buzz noise when using the audio system at high volumes, bass levels, or voice broadcasts. A small piece of casting flash on the lower map pocket contacting the door panel is the source of the noise.

1. Obtain a piece of soft PVC foam (164-R4901) from the Rotunda Squeak and Rattle Repair Kit (164-R4900)
2. Cut a 1/2" (12.7 mm) wide strip of soft PVC foam lengthwise.
3. Using a Trim Stick or suitable tool gently push the 1/2" (12.7 mm) wide strip of soft PVC foam between the lower edge of the map pocket and door panel. Center the PVC foam under the door grab handle. (Figure 1)
