FORD:

2010 Mustang, Explorer Sport Trac, Explorer

This article supersedes TSB **10-5-4** to update the Part List, Service Procedure and Service Labor Time Standards.

TSB 10-18-11 (Continued)

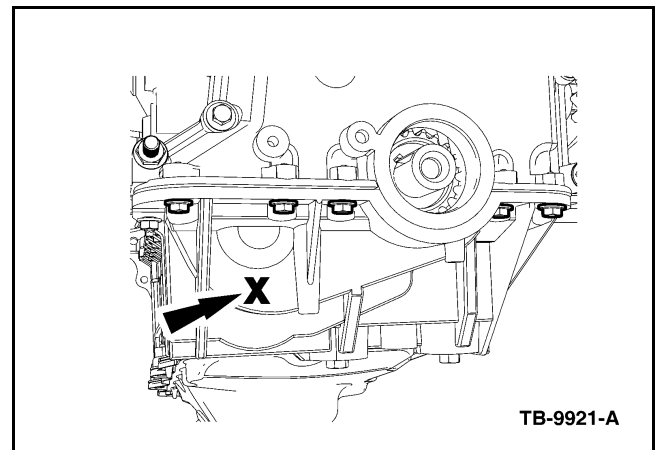
Figure 1 - Article 10-18-11

Vehicle exhibits engine rattle, worse in drive, between idle and 1100 RPM. No DTCs stored in powertrain control module (PCM).

1. Using a stethoscope, check for rattle-type noise near the front of the engine block cradle. (Figure 1)

- a. If rattle-type noise is not present in this area, do not continue with this procedure. Follow normal WSM diagnostics for noise.
 - b. If rattle-type noise is present near the front of the engine block cradle, proceed to Step 2.
2. Remove cylinder block cradle. Refer to WSM, Section 303-01A.

3. Replace the balance shaft sprocket. Use Kit A - Timing Gear Set Balance Shaft. While servicing the balance shaft sprocket, determine if the balance shaft assembly spins freely.
 - a. No - Balance shaft assembly does not spin freely, proceed to balance shaft replacement procedure.
 - b. Yes - Balance shaft assembly spins freely, proceed to Step 4.
4. Clean and reinstall cylinder block cradle, Refer to WSM, Section 303-01A.
5. Replace engine oil and oil filter.
