FORD:

2011-2012 Mustang, F-150

This article supersedes TSB 11-12-12 to update the Service Procedure and warranty causal part number.

TSB 12-3-1 (Continued)

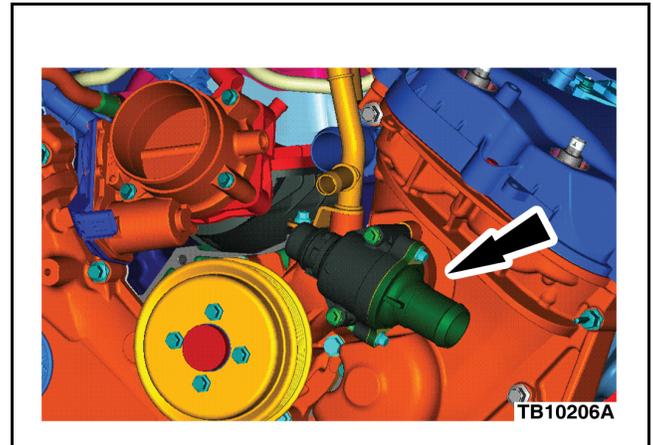
Figure 1 - Article 12-3-1

Some 2011-2012 F-150 and Mustang vehicles (excluding Boss) equipped with a 5.0L engine may exhibit an intermittent metallic rattle or scratching type noise in the area at the front of the left hand or driver side cylinder head at idle with the engine at operating temperature.

1. Determine engine build date. Refer to Workshop Manual (WSM), Section 303-01.
 - a. If engine build date is on or before 11/10/2011, proceed to Step 2.
 - b. If engine build date is on or after 11/11/2011, do not continue with this procedure. Refer to the WSM, Section 303-00 for normal diagnostics.
2. Warm the engine to operating temperature.
3. Using a mechanic's stethoscope or EngineEAR, listen for a metallic type rattle or scratching type noise at the front of LH cylinder head.
4. Is the noise heard in areas shown? (Figures 1 and 2)

- a. Yes - Proceed to Step 5.
 - b. No - This article does not apply.
5. Remove accessory drive belt, refer to WSM, Section 303-05. Is noise still present?
 - a. Yes - Proceed to Step 6.
 - b. No - Replace the coolant pump. Refer to WSM, Section 303-03A.
 6. Is the noise heard in the areas shown? (Figures 1 and 2)

- a. Yes - Replace the LH primary tensioner and timing chain tensioner arm using the kit part number provided in this article. Refer to WSM, Section 303-01B.
- b. No - This article does not apply. Refer to WSM, Section 303-00 for normal diagnostics.
