2003-2005 Thunderbird  
 2005-2006 Mustang  
 2006-2008 Fusion  
 2004-2005 Explorer  
 2005-2006 Expedition  
 2005-2007 F-150

**ISSUE**

## TSB 12-8-1 (Continued)

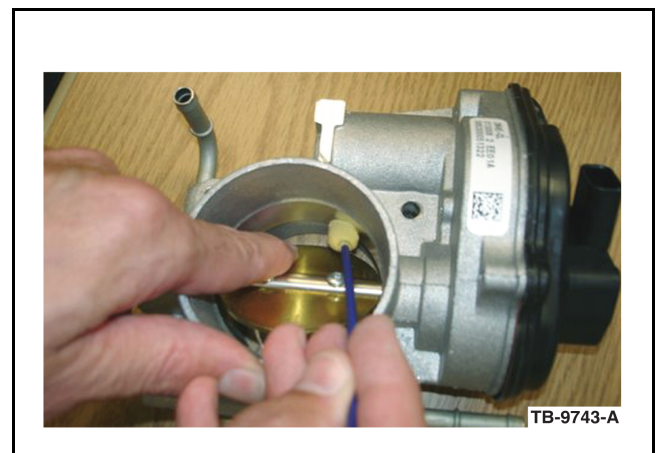
Figure 1 - Article 12-8-1

Various vehicles may exhibit Diagnostic Trouble Codes (DTC) P0505, P0506 and/or engine idle RPM fluctuation and hard starts. Some vehicles may also exhibit DTCs P2111 and P2112 after a keep alive memory (KAM) clear, battery disconnect or dead battery. On vehicles with over 10,000 miles, the issue may be caused by sludge buildup in the throttle body leading to less than desired airflow.

3. Using Integrated Diagnostic System (IDS) scan tool or equivalent, monitor the PID values of IACTRIM and IACKAM2 while the engine is running. The sum of IACTRIM and IACKAM2 is the total IAC. Is the total IAC greater than 0.5 lb/min?
  - a. Yes - proceed to Step 4.
  - b. No - this article does not apply. Refer to Powertrain Control/Emissions Diagnosis (PC/ED) manual for normal diagnostics.
4. Remove the throttle body. Refer to Workshop Manual (WSM), Section 303-04.
5. Using Motorcraft® Choke and Linkage Cleaner or equivalent, spray the throttle body plate and bore. Using a small, soft, solvent-resistant brush, clean the edges of the throttle plate and the mating surface of the throttle bore to remove all engine deposits. (Figures 1-2)
