INTERMITTENT NO START AND/OR ROUGH RUNNING—BLOWN FUSE 13—DTC P0627

TSB 12-11-12

FORD:
2011-2013 Mustang

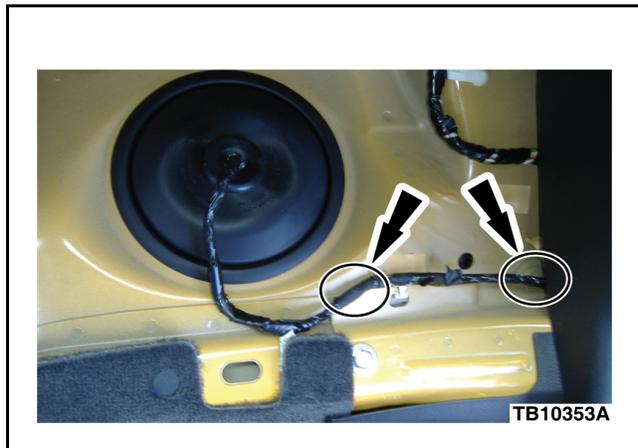
Figure 1 - Article 12-11-12

1. Remove the rear seat cushion. Refer to Workshop Manual (WSM), Section 501-10.
2. Inspect the fuel pump module wire harness for a chafing. Is chafing found? (Figure 1)

- a. No - this article does not apply. Refer to Powertrain Control/Emissions Diagnosis (PC/ED) manual for normal diagnosis.
 - b. Yes - repair the wiring harness. Refer to the Wiring Diagram (WD), Section 5.
3. Route the harness so that it will lie in the recess area of the rear seat when the seat cushion is installed. (Figure 2)
