2017 Ford Mustang V8-5.0L

EXCESSIVE PANEL GAP BETWEEN REAR BUMPER COVER AND REAR QUARTER PANELS - BUILT ON OR BEFORE 26-FEB-2018

18-2107

Ford
2015-2018 Mustang

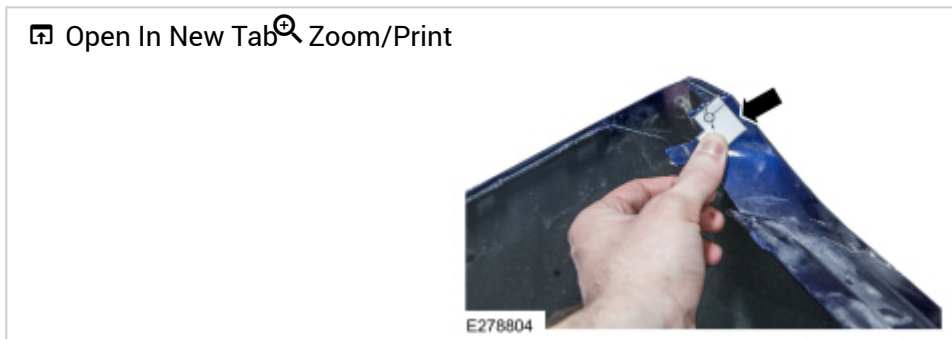
Figure 2

(1). To locate where the holes should be before drilling, align the cutout corner of the template with the notch along the front edge of this part of the fascia. (Figure 2, right side shown)

4. Use the provided templates to drill a 13/64" hole in each side of the bumper cover.

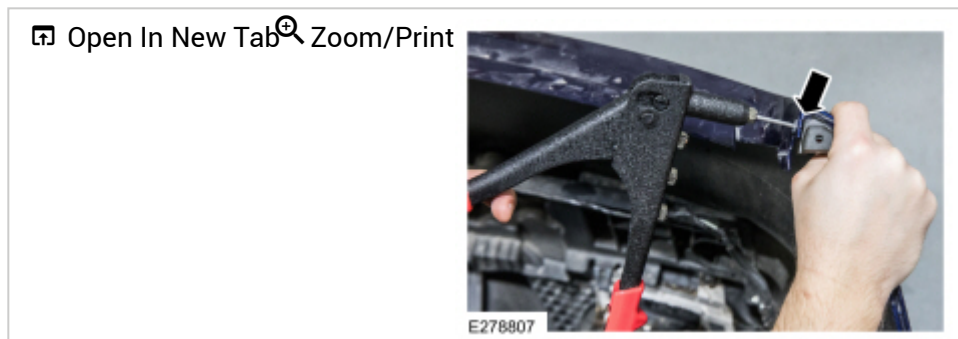
Figure 5

(3). Fasten the rivets with a rivet gun, holding the compression wedge in place to make sure each one is seated and the double-sided tape adheres properly. (Figure 5, left side shown.)

7. Install the compression wedges to the bumper cover.

(1). Remove the backing from the double-sided tape on the compression wedges and install them into the bumper cover.

(2). Insert the rivet through the holes in the bumper cover and the holes in the compression wedges.

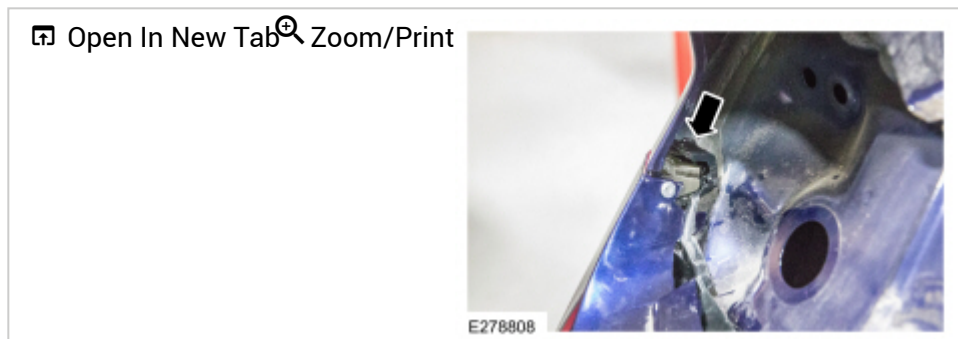
Figure 6

9. Align the top hole of the compression wedges to the hole that is present on the rear outer bracket. An assistant may be necessary to lift up on the bumper cover to allow the holes to line up. Using the provided bolts, install one on each side. Start the bolts by hand, but do not tighten. (Figures 6 - 7, left side shown)

10. Once the bumper cover is loosely installed, visually align the bumper cover on the vehicle for the best appearance and fit. While having an assistant lift up on the bumper cover, tighten the bolts installed in Step 9 to 1.5 Nm (13 lb-in).
