2019 Ford Mustang V8-5.0L

TECHNICAL SERVICE BULLETIN  
SEAT PAN LOOSENESS, LATERAL  
MOVEMENT, OR CLUNK/THUMP  
NOISE ON TURNS

18-2361

03 December 2018

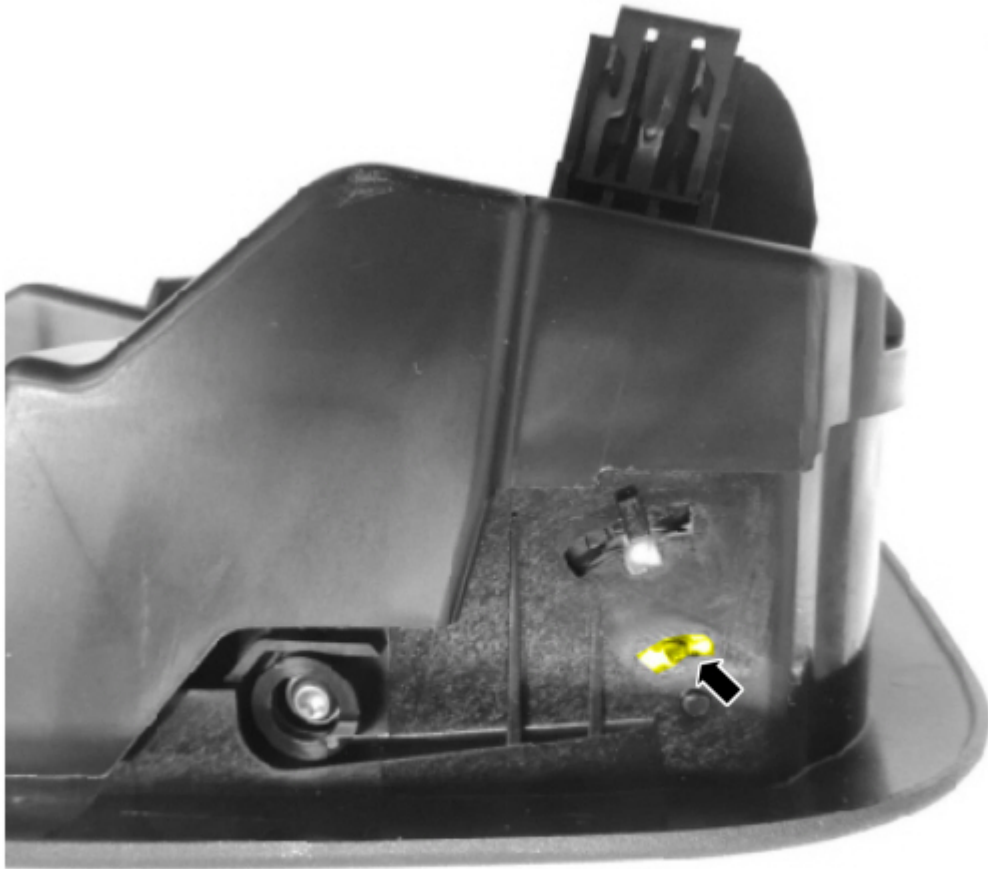
Figure 2

**5. Cut a 25.4 mm (1 in.) long section of 19 mm (3/4 in.) diameter heater hose. (Figure 2)**
