# Door Chime Repair

Over time the foam surround on the speaker inside the 1991 and 1992 Mustang's door chime module disintegrates and the chime module gets quiet or stops working altogether. This kit uses a o'ring of the right size and stiffness to restore the volume of your door chime. Includes detailed instructions.

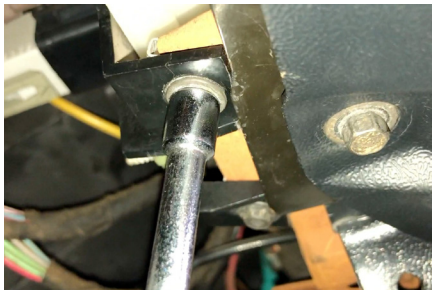
## Step 1

The door chime module on 1990-1991 Mustangs is under the dashboard near the steering column. Locate, unplug, and remove it from the car.

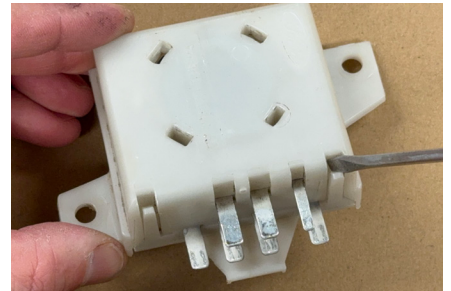
## Step 2

Use a small screwdriver to open the module case.

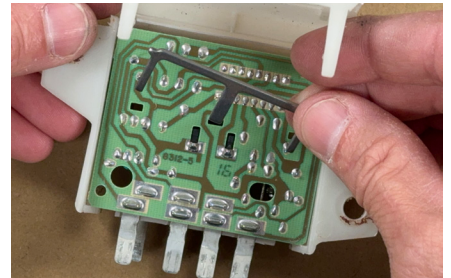
## Step 3

Disassemble the module.

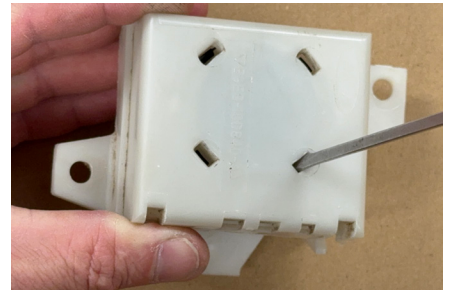
## Step 4

Use a small screwdriver to release the tabs on the speaker frame and remove the speaker disc.

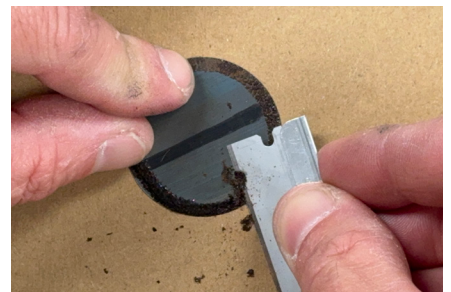
## Step 5

Scrape what remains of the foam speaker surround with a razor blade. Reinstall the speaker disk.

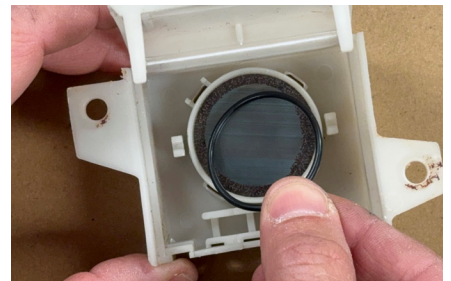
## Step 6

Install the included o-ring over the speaker disc and reassemble the module
