TECHNICAL SERVICE BULLETIN

2021-2022 Bronco - Soft Top Roof – Excessive Wind Noise, Loose Cover, And/Or Difficulty Latching

22-2296

Ford 2021-2022 Bronco

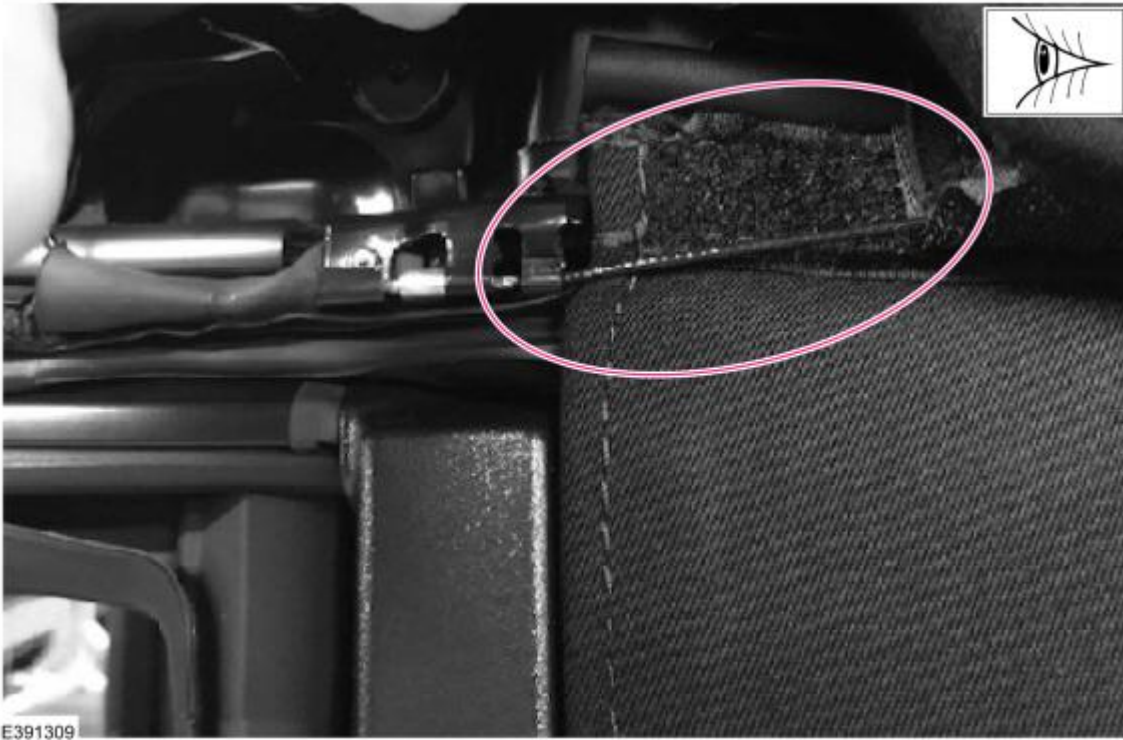
Figure 1 - Left side shown, right side similar

1. Inspect both rear quarter windows and rear window attachments. For window operation, refer to the Digital Owner’s Manual located in the vehicle’s center touch screen by selecting Features > Owner’s Manual > Removable Vehicle Components > Removable Soft Top > Opening and Closing the Soft Top.
 - (1). Inspect the rear quarter windows for damage and properly securement at the C and D-pillars.
 - (2). Inspect all window upper buckles to be sure they are free of damage and properly secured. Adjust or repair as necessary.
 - (3). Inspect the hook and loop fasteners that run along the top of the windows making sure they are free of damage and properly secured at all locations. Adjust or repair as necessary.
 - (4). Inspect the tension cable routing as it relates to the rear quarter window. The rear quarter window should be tucked behind the cable. (Figure 1)

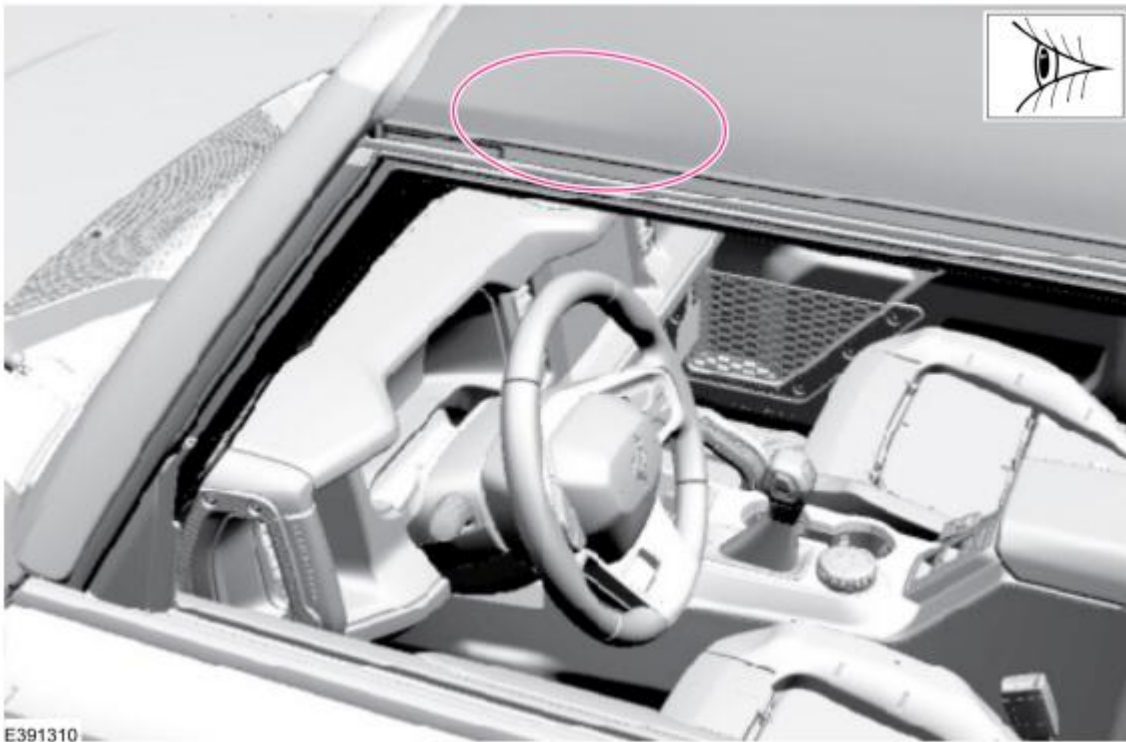
Figure 2 - Left side shown, right side similar

3. Locate the front tension cable brackets. These can be found on each side of the vehicle just above and behind the A-pillars. Lift this area of the soft top cover to gain access. (Figure 2)

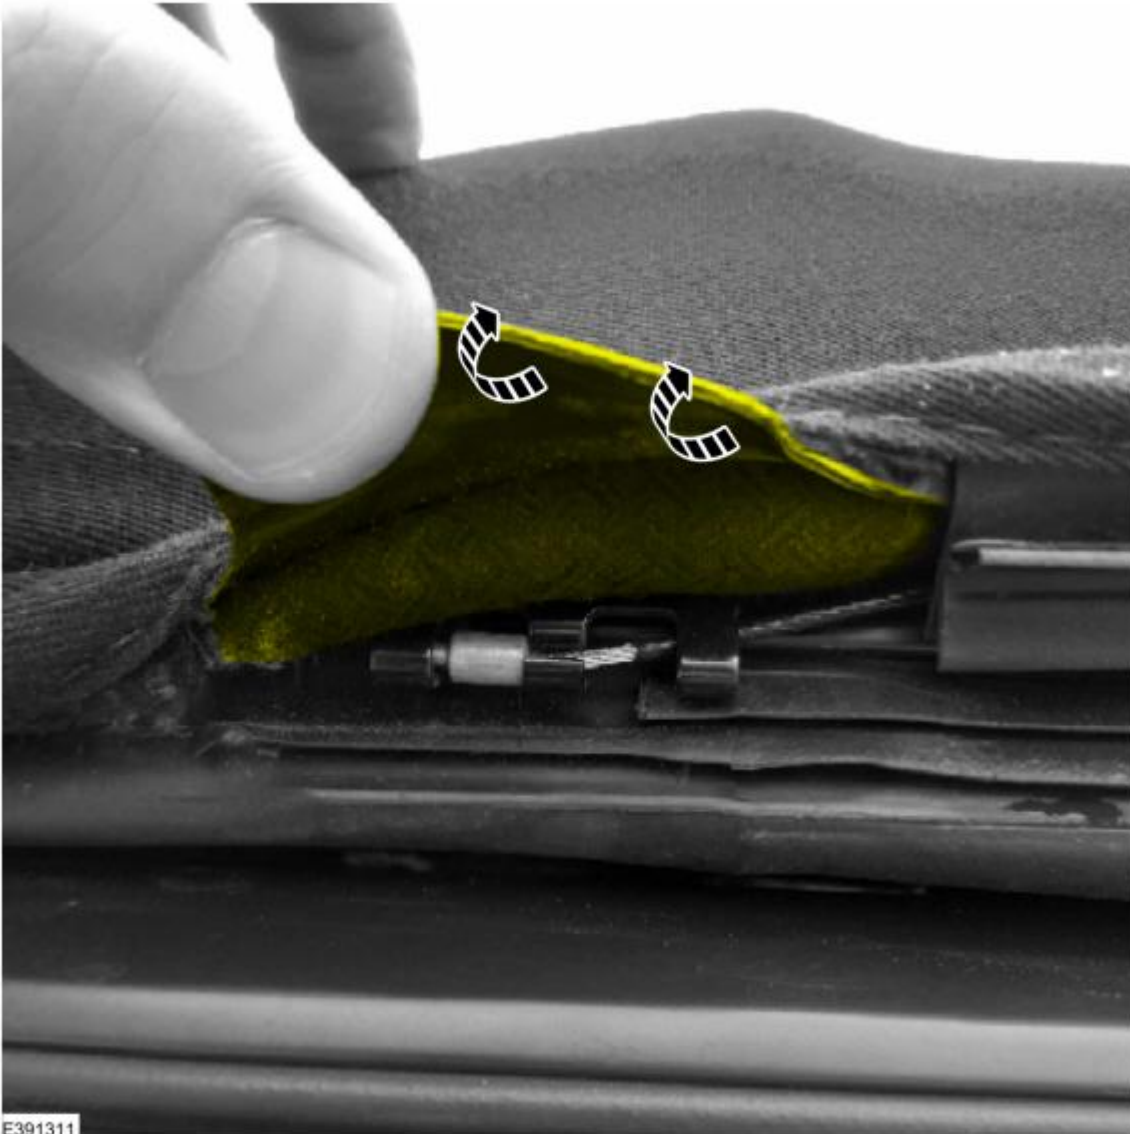
Figure 3 - Left side shown, right side similar

- (1). Disengage and lift the plastic flap covering the bracket out of the way. (Figure 3)

(2). Be sure the cable lobe is secured in the most vehicle-forward position. (Figure 3). Adjust or repair as necessary.

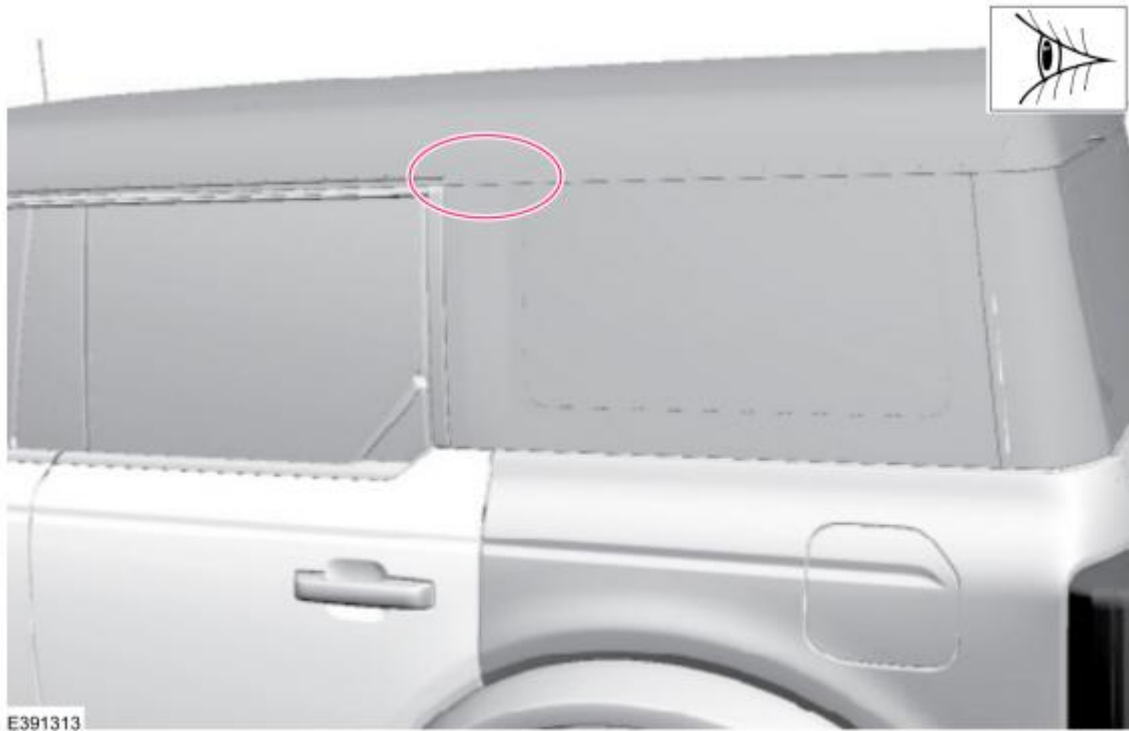
Figure 5 - Left side shown, right side similar

(1). Locate the rear tension cable brackets. These can be found on each side of the vehicle, just above C-pillars. Lift this area of the soft top cover to gain access. (Figure 5)
