6R80 TRANSMISSIONS—FLUID LEAK FROM BELL HOUSING—BUILT ON OR AFTER 4/15/2011 THROUGH 6/8/2011

TSB 12-11-14

2012 Mustang
2011 Expedition, F-150

2011 Navigator

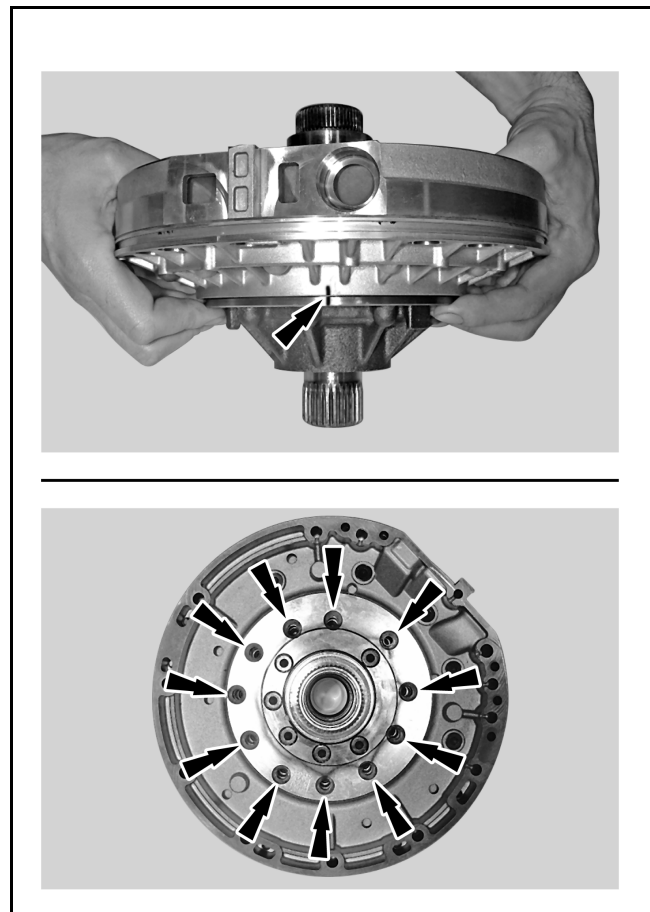
Figure 5 - Article 12-11-14

18. Lube new pump body and gear assembly outer pump body O-ring with clean transmission fluid and align new pump body and gear assembly to pump plate and stator and carefully install into the pump plate and stator. (Figure 5)

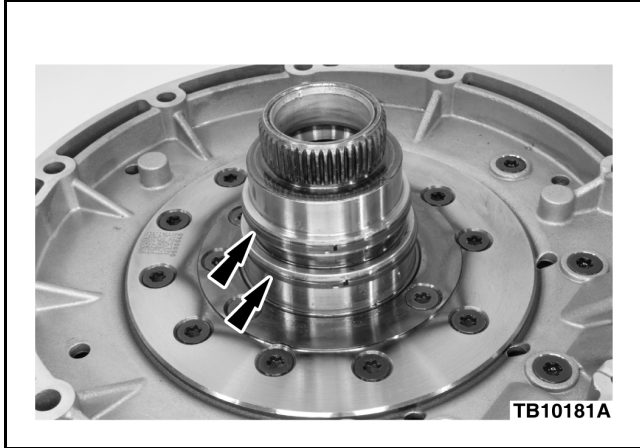
Figure 6 - Article 12-11-14

19. Install the pump plate assembly-to-front pump body bolts. Tighten to 15 N•m (133 lb-in).
20. Inspect pump stator seals replace if damaged. (Figure 6)

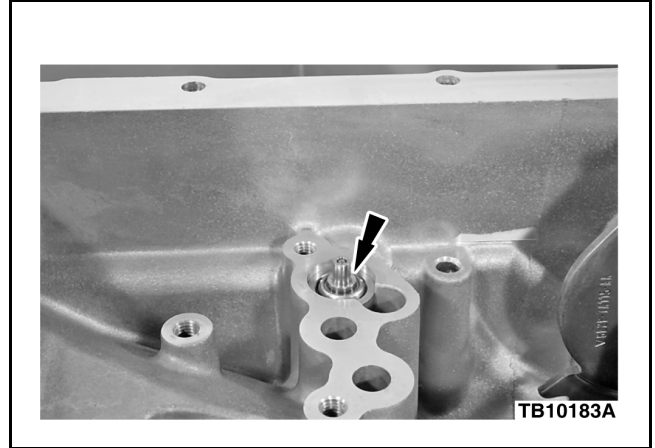
Figure 8 - Article 12-11-14

27. Add 11.8 cl (4 oz.) of clean transmission fluid through filter inlet to prime the pump.
28. Install the thermal bypass valve into the case. (Figure 8)
