2017 Ford Mustang V8-5.0L

TSB 16-0153	RIGHT HAND DRIVE - OIL LEAK FROM THE ENGINE OIL COOLER - BUILT ON OR BEFORE 26-JUL-2016
Publication Date: November 4, 2016

FORD: 2016-2017 MustangThis article supersedes TSB **16-0140** to add the predefined repair (PDR) codes.

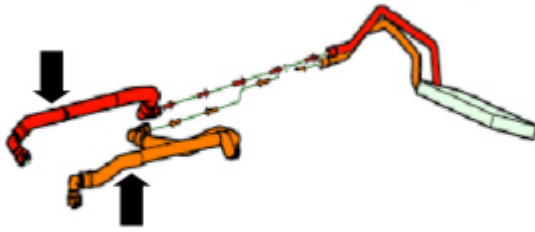
Figure 1 - 16-0153

1. Check the engine oil and coolant system for contamination. Is the engine oil contaminated with engine coolant or coolant contaminated with oil?
 - a. Yes - proceed to Step 3.
 - b. No - proceed to Step 2.
2. Replace the engine oil cooler. Refer to Workshop Manual (WSM), Section 303-03.
 - a. Add engine oil and coolant as necessary.
 - b. Repair is complete.
3. Replace the engine assembly. Refer to WSM, Section 303-01.
 - a. Perform Steps 4 through 8 of this article while the engine is removed.
4. Flush the heater core.
 - a. Cut both heater hoses at approximately the center of the hose.
 - b. Using a 19 mm (3/4") hose coupling adapter and a clamp connect a coupling adapter to the side of the cut heater inlet hose leading to the heater core. (Figures 1 and 2)

- c. Using a 19 mm (3/4") hose coupling adapter and a clamp connect another coupling adapter to the side of the cut heater outlet hose coming from the heater core. (Figures 1 and 2)
- d. Flush the heater core with hot water for 2 minutes.
- e. Blow out all water from the heater core with regulated shop air. Maximum 276 kPa (40 Psi).
- f. Fill the heater core with Simple Green® PRO HD Heavy Duty Cleaner and Degreaser or equivalent through one of the heater hoses. Install a 12 volt marine wash down pump similar to shown. (Figure 3)

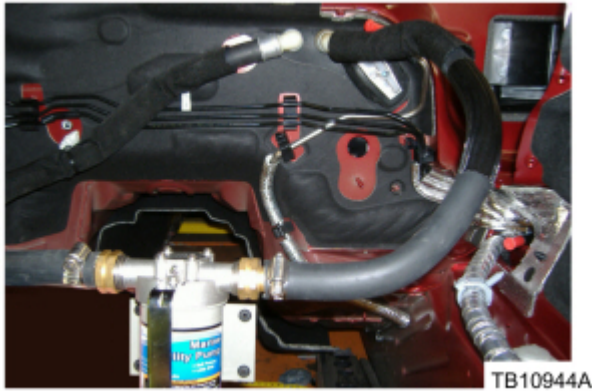
Figure 4 - 16-0153

g. Connect the heater hoses to the 12 volt marine wash down pump to create a closed loop. (Figure 4)

- h. Connect the 12 volt marine wash down pump to the vehicle battery with a battery charger hooked up. Run the 12 volt marine wash down pump for 20 minutes.
- i. Disconnect the 12 volt marine wash down pump from the vehicle battery and from the hoses. Run clear water through the heater core for 4 minutes.
- j. Discard the cut heater hoses.
