2016 Ford Mustang V8-5.0L

CLIMATE CONTROLLED SEATS - LACK OF COOLING - FRONT SEAT BACKREST

TSB 15-0144	CLIMATE CONTROLLED SEATS - LACK OF COOLING - FRONT SEAT BACKREST
Publication Date: September 22, 2015

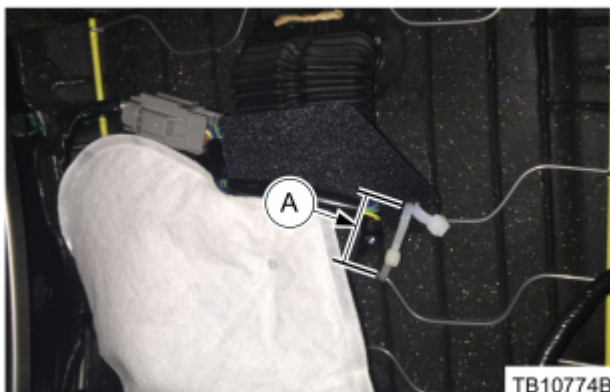
Figure 1 - 15-0144

1. Perform the procedure on both seats.
2. Does the vehicle exhibit a lack of cooling from the front seat backrest when using the climate controlled seat?
 - a. Yes - proceed to Step 3.
 - b. No - this article does not apply. Refer to Workshop Manual (WSM), Section 501-10 for normal diagnostics.
3. Can the front seat backrest blower motor be heard running when using the climate controlled seats?
 - a. Yes - proceed to Step 4.
 - b. No - this article does not apply. Refer to WSM, Section 501-10 for normal diagnostics.
4. Remove the front seat backrest blower motor. Refer to WSM, Section 501-10.
5. Install a new front seat backrest blower motor. Refer to WSM, Section 501-10.
 - a. Secure the new front seat backrest blower motor with a tie strap leaving 25 mm (1 inch) of slack in the tie strap. (Figure 1A)

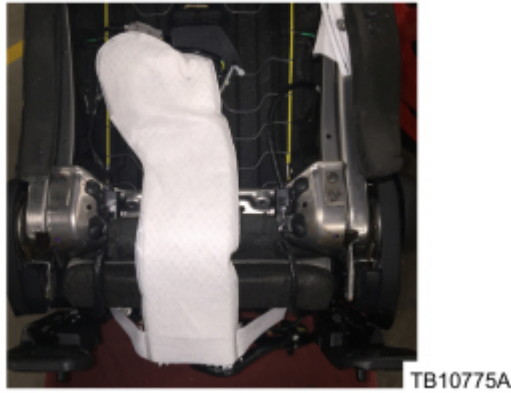
Figure 2 - 15-0144

b. Route the air intake snorkel of the new blower motor as shown. (Figure 2)

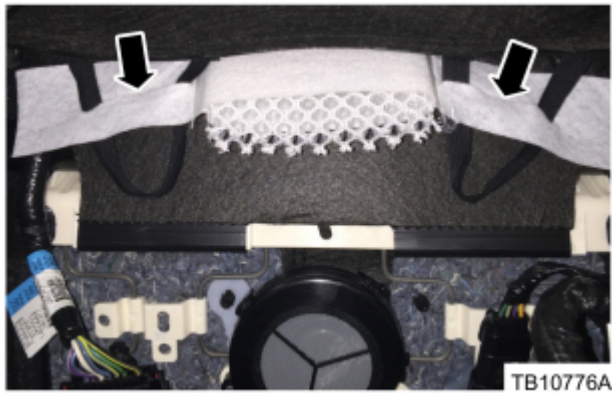
Figure 3 - 15-0144

a. Route the elastic backrest cover straps through the slots in the fabric at the end of the air intake snorkel prior to refastening the elastic backrest cover straps. (Figure 3)

6. Reinstall the seat backrest cover. Refer to WSM, Section 501-10.
