2017 Ford Mustang V8-5.0L

CONVERTIBLE - ROOF SAGGING AT THE REAR GLASS

18-2036
06 February 2018

Ford
2015-2018 Mustang

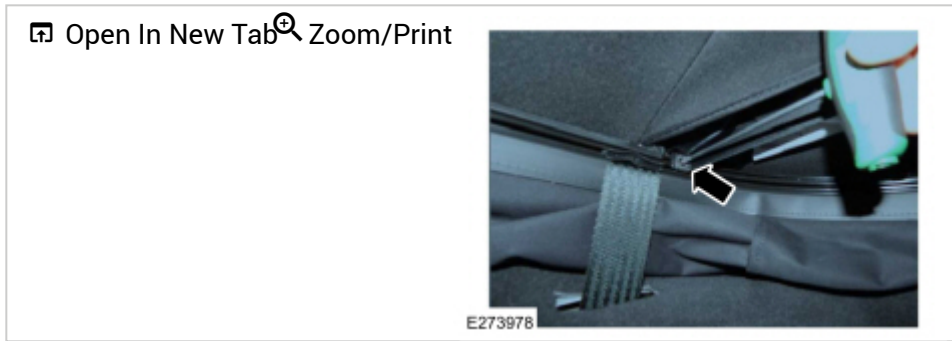
Figure 1

3. Disconnect the convertible top tension belt from the rear bow. (Figure 1)

14. Connect the convertible top tension belt. (Figure 1)

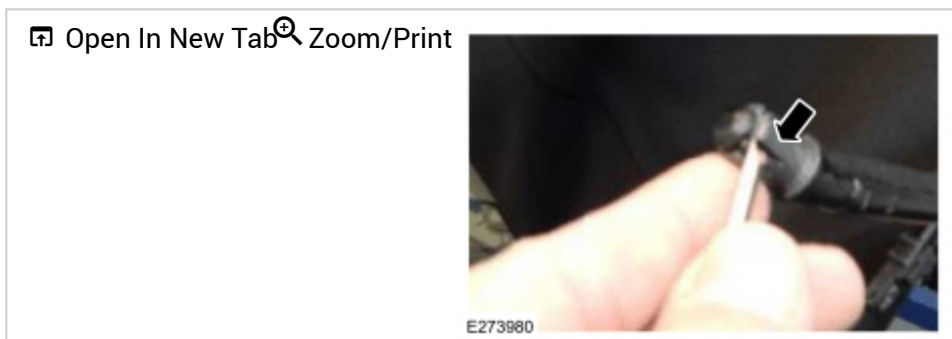
Figure 3

**5. Using a small flat blade screwdriver, pry the rear glass tension rod clips open and remove the clips. (Figure 3)**

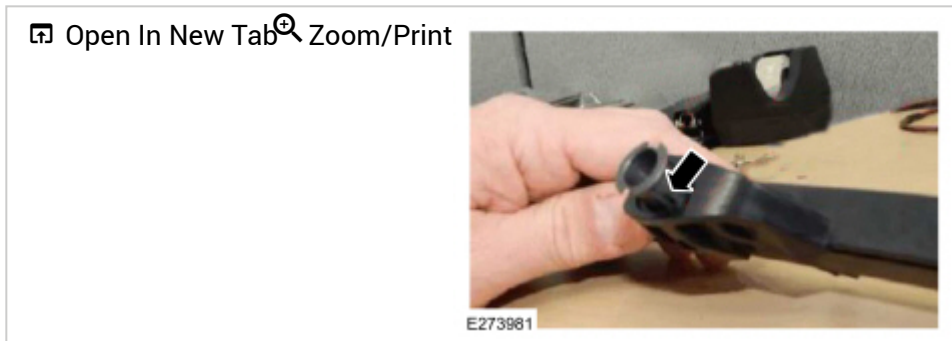
Figure 4

**6. Install new clips onto the rear glass tension rod ends. Note the alignment rib and make sure the clips are oriented for proper installation into the rear glass frame. (Figure 4)**

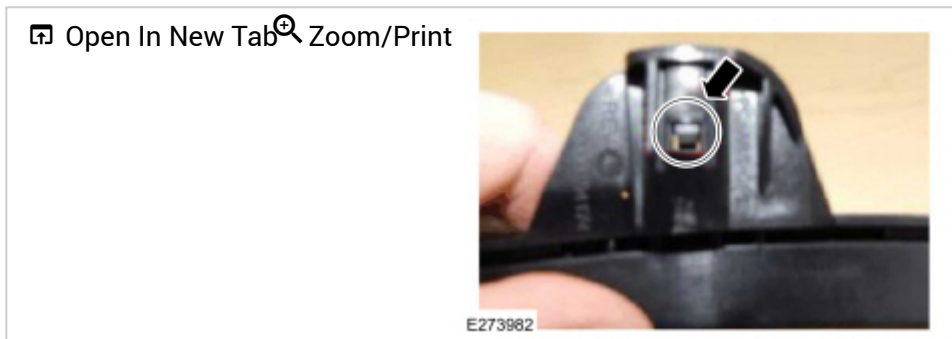
Figure 5

8. Insert the rear glass tension rods into the rear glass frame. Verify the clip is installed securely into the frame and the locking tab is visible as shown. Use of a mirror may be necessary. Pull on the clip slightly to verify the clip is fully locked. (Figure 5)

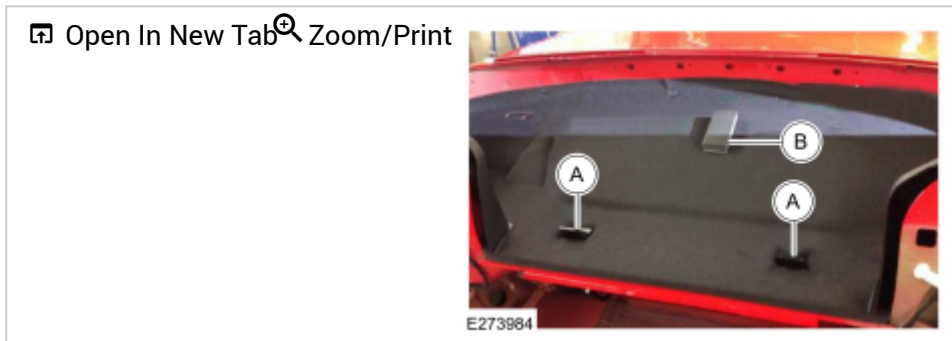
Figure 7

10. Remove the plastic child seat tether covers. (Figure 7, A)

12. Install the foam block as shown. (Figure 7, B)

16. Install the plastic child seat tether covers. (Figure 7, A)
