TECHNICAL SERVICE BULLETIN

Rubberized Flooring - White Chalky/Dull Appearance

22-2036
10 February 2022

Ford 2021-2022 Bronco

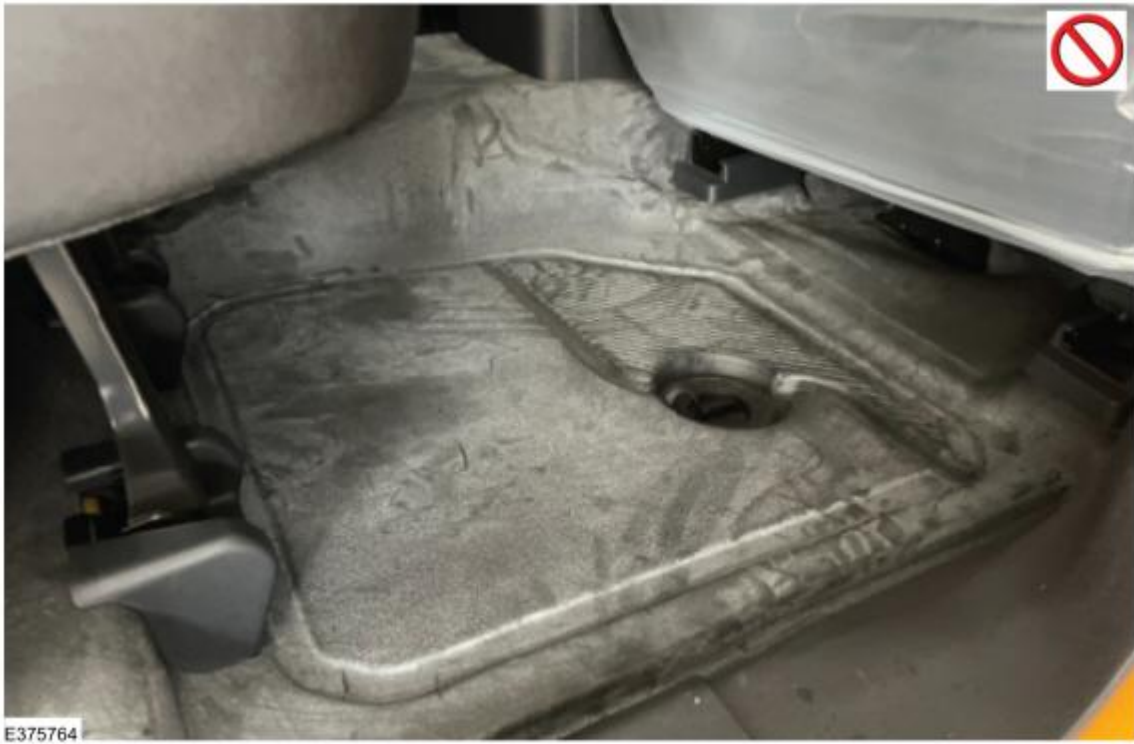
Figure 1 - Before cleaning

Issue: Some 2021-2022 Bronco vehicles equipped with rubberized flooring may encounter a white chalky/dull appearance due to excessive wax raising from the surface. To correct this condition, follow the Service Procedure to clean the rubberized floor.

NOTE: While scrubbing, crystals of the wax (white/chalk) may accumulate in the lower areas of the flooring.

1. Vacuum the vehicle floor to remove any dirt and loose debris.
2. Scrub the surface with a clean, dry nylon bristled brush. It may be necessary to scrub with more intensity over areas of the flooring that are more contoured. (Figures 1 before vs Figure 2 after).
